# uMngeni River Source to Sea Walk

30 April to 28 May 2012

Compiled by Penny Rees  
Duzi uMngeni Conservation Trust (DUCT)

July 2014

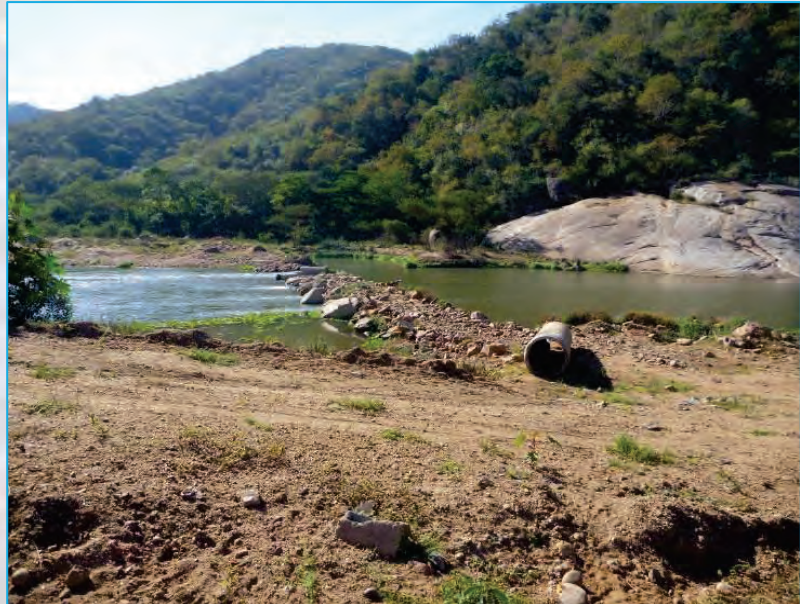
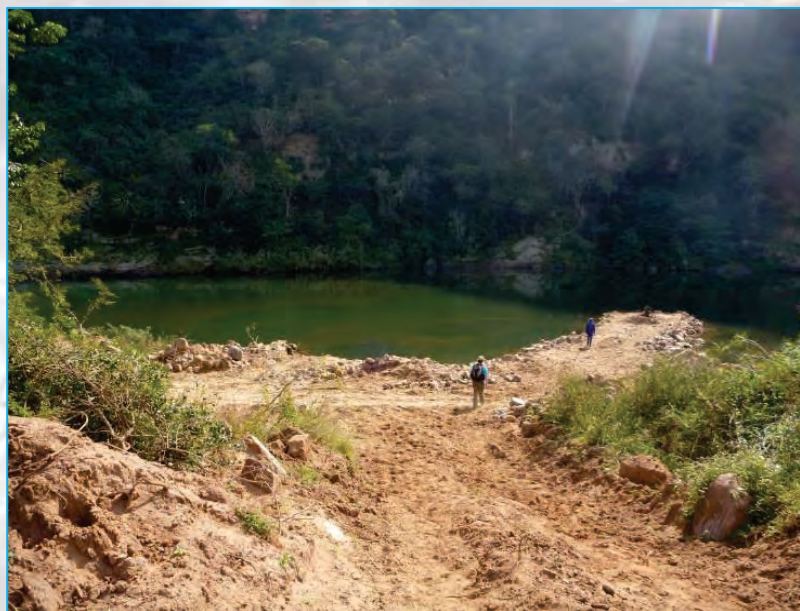
As long as there is construction, there will be sand mines. Sand mining on the uMngeni River seems to be uncontrolled, and many of the mines are illegal. In addition, few seem to be rehabilitated (which is a legal requirement); many destroy the riverbank vegetation and build causeways across the river, which are both illegal activities, and disturbed areas in abandoned mines become a seeding ground for invasive plants which then spread to surrounding areas. Some mines have been rehabilitated. However, from the area around the uMsunduzi confluence all the way into Durban we logged 45 mines. Of these, possibly 10 were active, the others all mined out or abandoned – clearly with no rehabilitation whatsoever. Mining permits are issued by Department of Mineral Resources, with little or no consultation with the Departments of Water Affairs and Environmental Affairs. There does not seem to be any compliance monitoring nor law enforcement.

The mining sometimes affects local communities – in some places, people can no longer get across the river due to the depth of digging, and thus cannot get to a shop or visit friends or family across the river. In other cases fishing, on which many depend for protein, has been negatively affected.

*Top: Abandoned sand mine upstream of Inanda Dam  
Bottom: Active sand mine near Durban*

the sand from migrating downstream and renewing our beaches. A recommendation was made that an ideal area to mine sand is the inlet to Inanda Dam. This is an area that is already impacted, and removal of this sand would prevent it from entering the dam and causing loss of capacity through siltation. Sand mining below Inanda should be prevented, to allow whatever sand is left below Inanda Dam to be carried into the ocean to replenish the beaches of Durban.

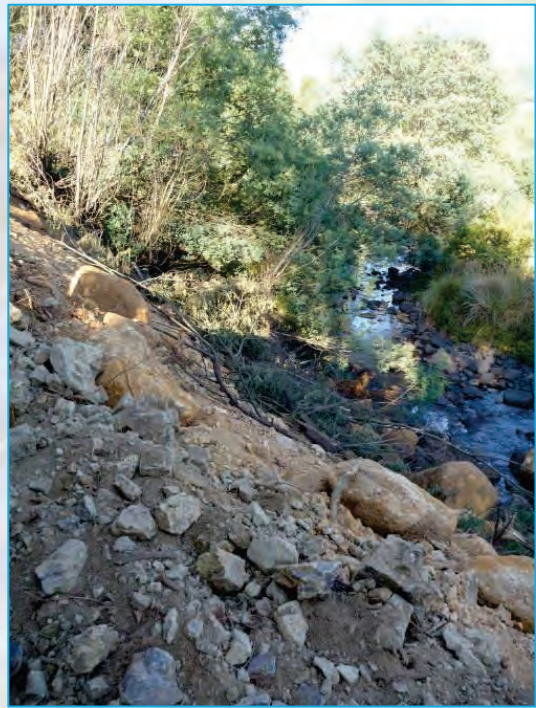
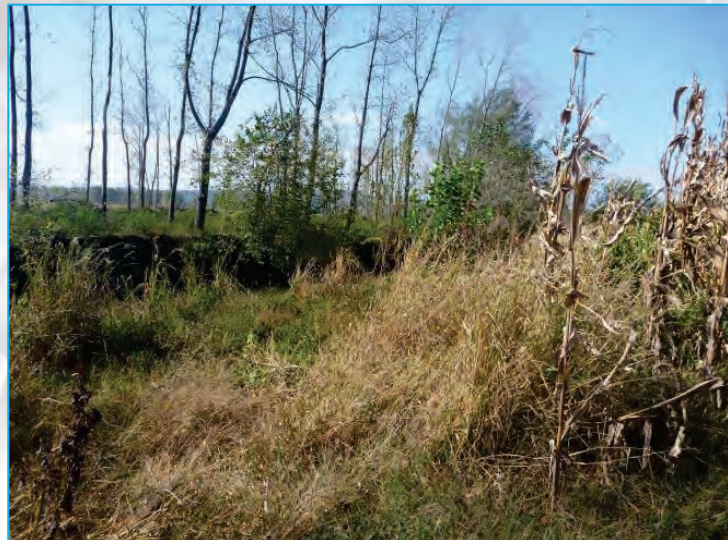
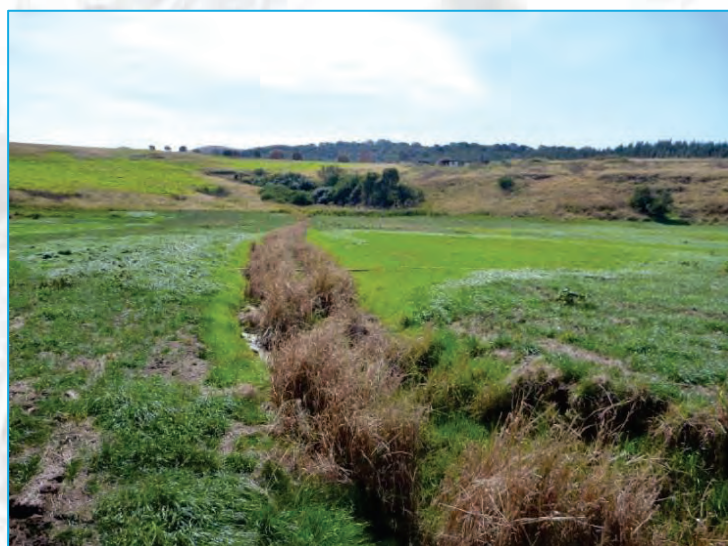
Top: Bulldozed river bank

Middle: Poplars and maize in buffer

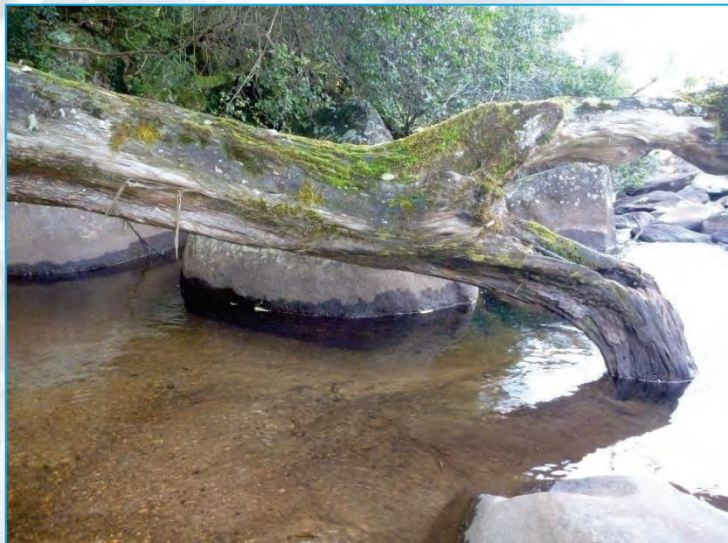
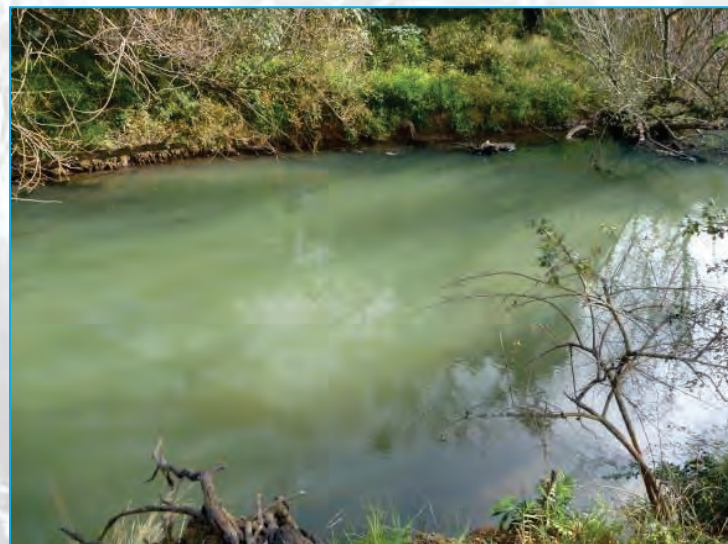
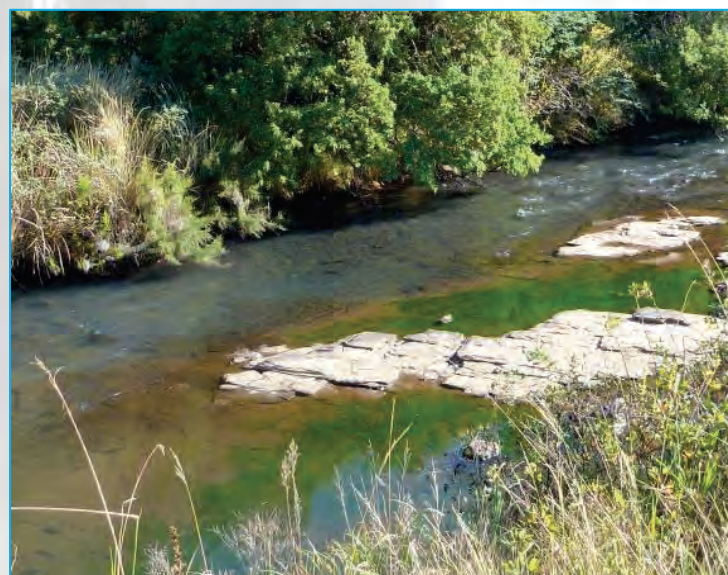
Top: Crystal clear water in the source gorge  
Middle: Turbid grey water – dairy farm  
Bottom: Algal bloom – poultry farm

Impacted areas often showed signs of poor water quality such as silt on the river bed, white stains on the rocks; algae and aquatic water plants, algal “sludge” on the rocks and water with a grey green milky hue or general turbidity. (See Appendix 7.)

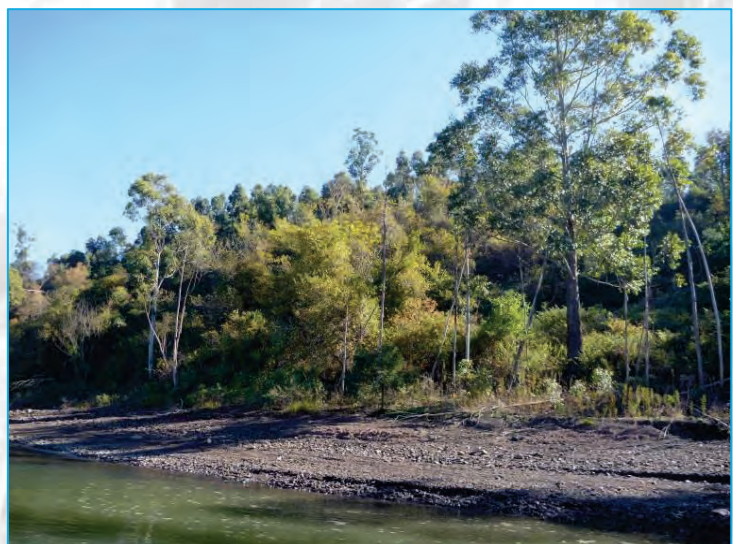
Photo: Invasive vegetation on shore

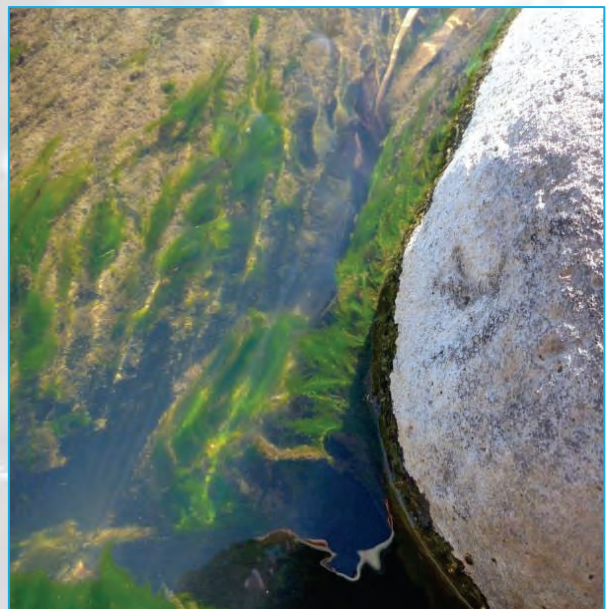
The uMngeni inlet comprises a small sheltered bay, with rapids at its upper end. Heavy sediment and heavy infestations of algae were seen on the rocks of the rapids, the submerged river rocks and in the river water itself and fertiliser stains were observed on exposed rocks. The bay of the inlet had very turbid water with a lot of algae, duck weed and water lettuce in a floating “raft”.

*Right: Fertiliser stains and algae – Albert Falls Dam headwaters*

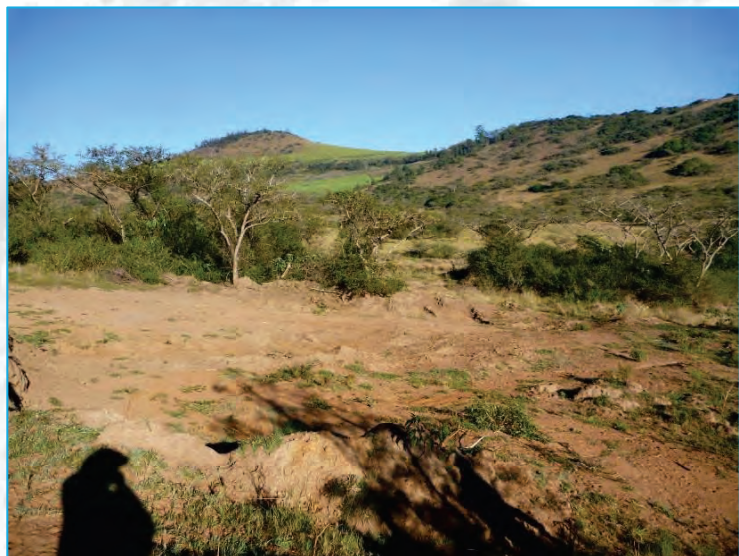
Right: Sand Mining

Along the stretch of river downstream of Cumberland Nature Reserve and as far as Nagle Dam one operational and three abandoned, un-rehabilitated sand mines were recorded. We saw repeated signs of non-rehabilitation where the old flood plains are like the surface of the moon, filled with craters, piles of boulders and the occasional small hillock which is home to a large tree. Some of these hillocks stand over 2 metres above the rest of the area, indicating the depth to which the sand was

removed. Veld condition here varies between areas choked with invasives, to areas with a mixture of pioneer plants and invasives and even some areas where the vegetation succession is more progressed. The un-rehabilitated sand mining sites definitely have higher invasive plant infestations than other areas, and seem to be promoting colonisation by invasive plants. (See Appendix 6.)

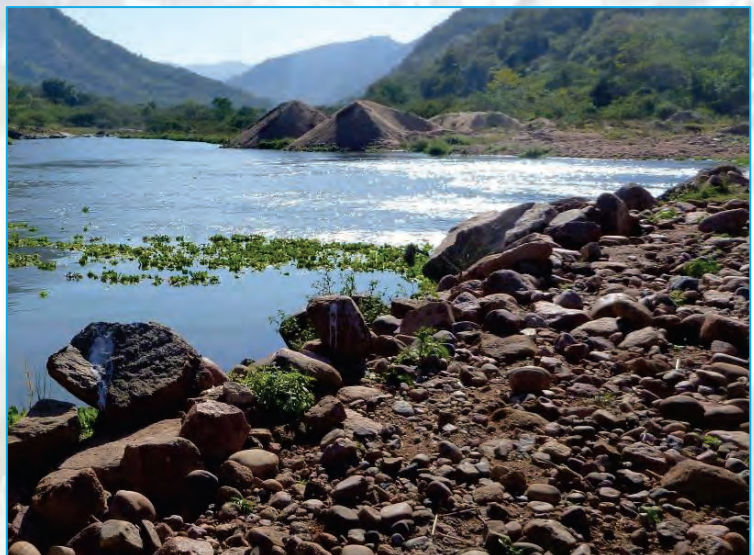
The active mines vary between excavators dredging in the river and heaping mountains of sand on the river banks awaiting removal, to earthworks and digging of the actual river banks, often within the 32 metre buffer area, which in some places has been stripped bare. We witnessed rock causeways that have been built across the river, some with only three pipes to allow for water flow, and these causeways act as small dams. Earth moving equipment moves haphazardly up and down the river banks, destroying all riparian vegetation.

Top: Young Podocarpus (Yellowwood) forest  
Bottom: Abandoned sand mine and causeway

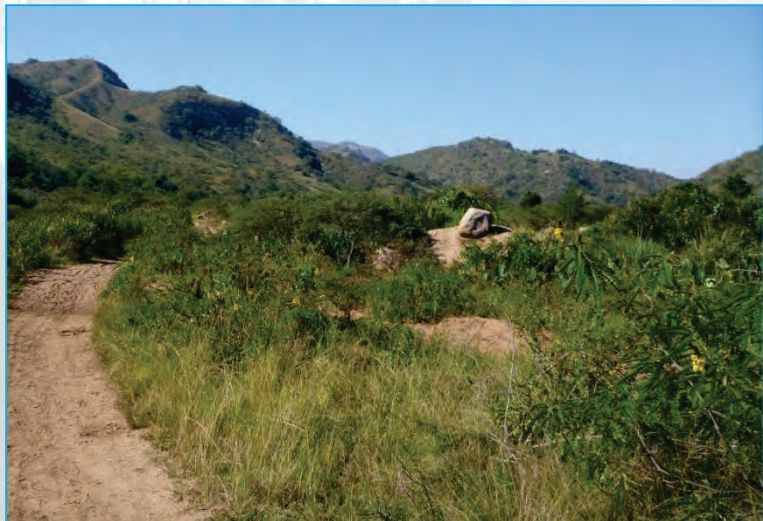
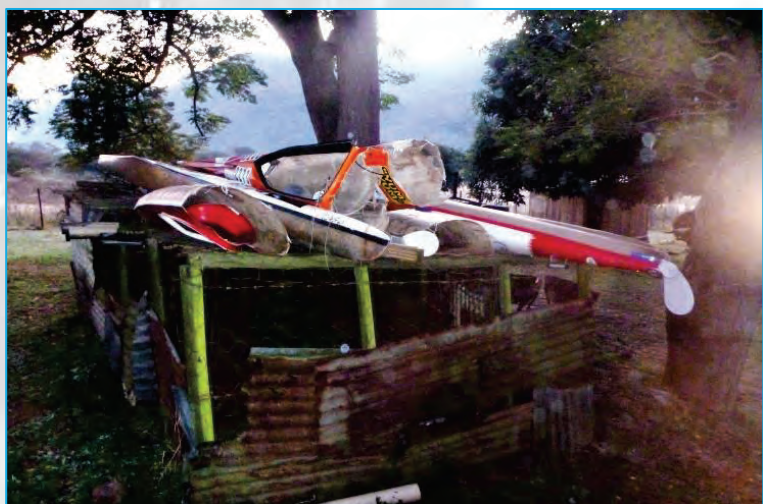
*Top: Abandoned sand mine infested with Peanut Butter Cassia  
Bottom: Broken canoes collected from the river*

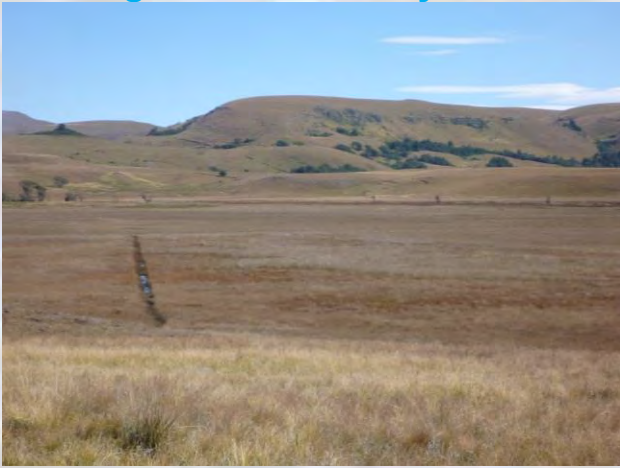
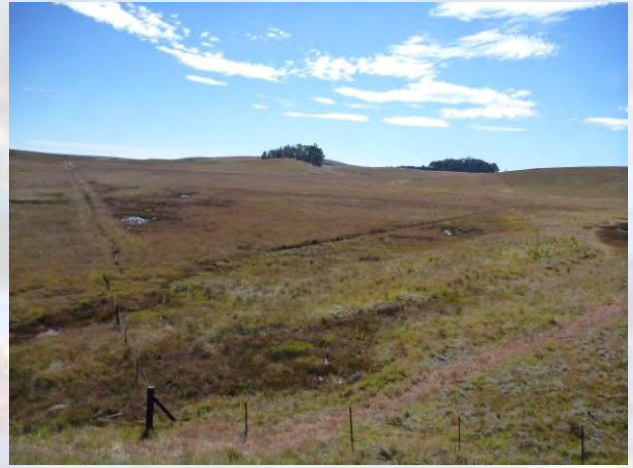
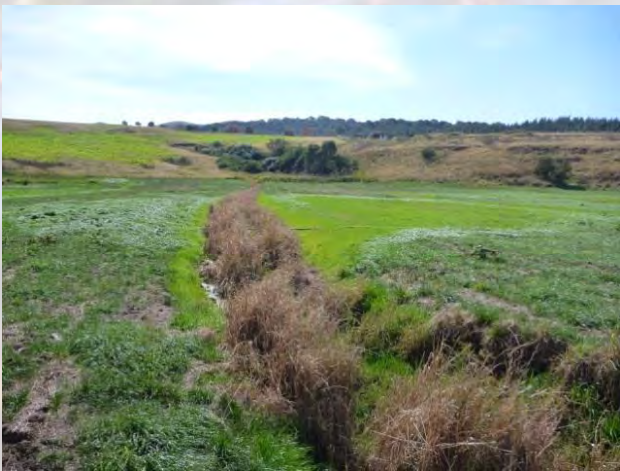
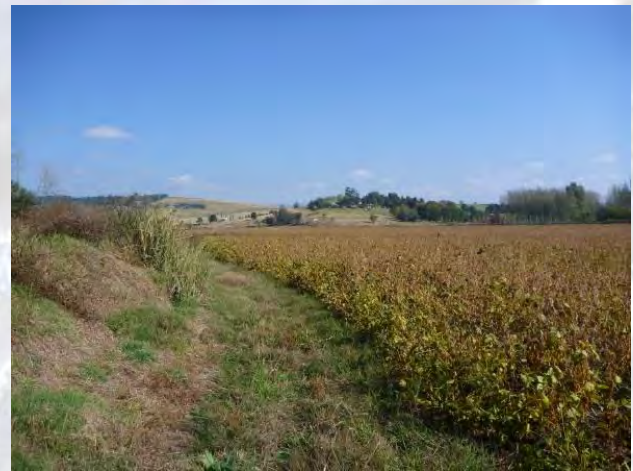
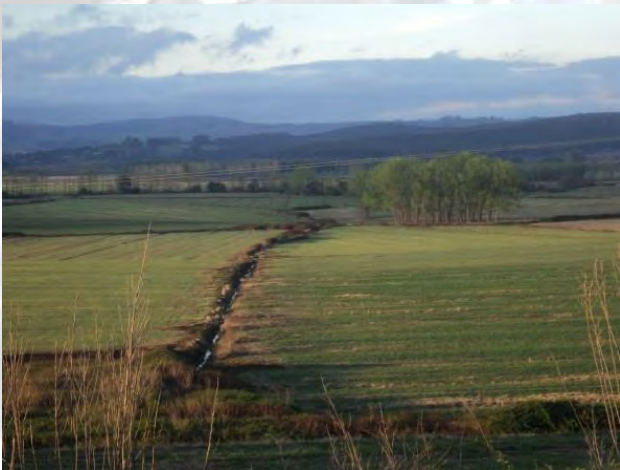
*Top right: Source Plateau: Ditches to drain wetlands (historical)  
Bottom right: Upstream of Midmar: Dyke (to left of photo)*

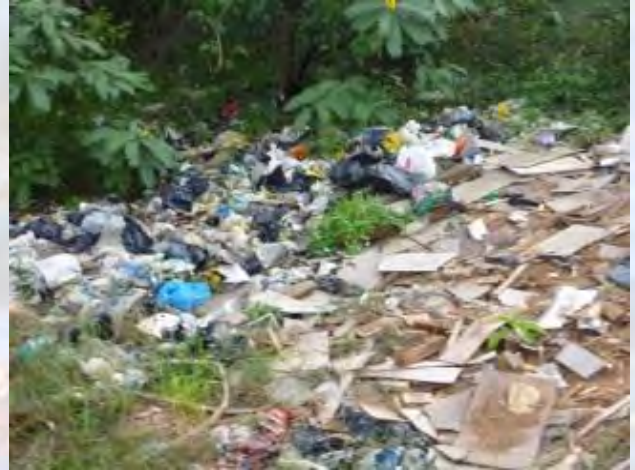
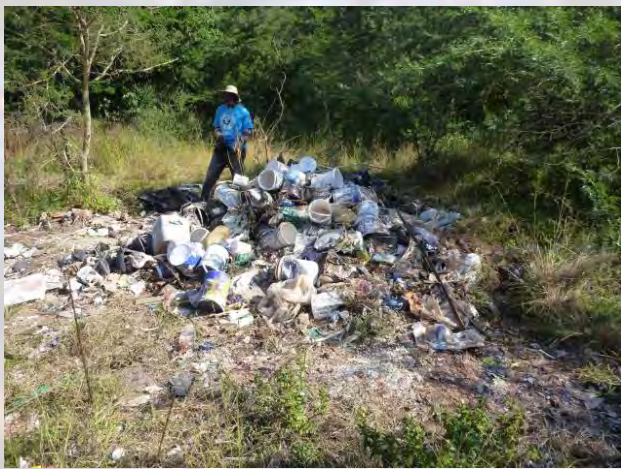
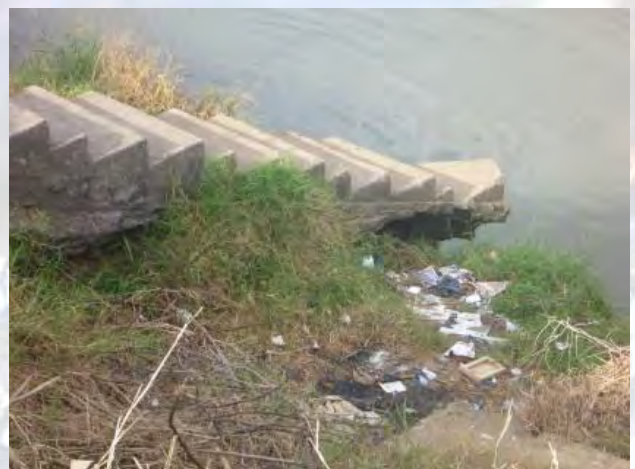
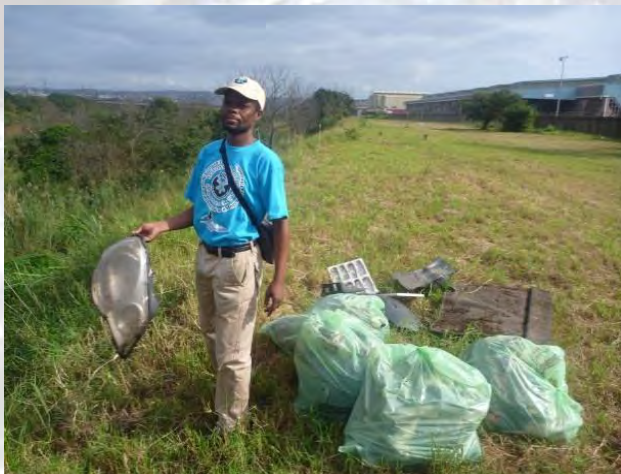
*Top right: Durban: Dumping  
Bottom right: Industrial area: Wind blown litter*

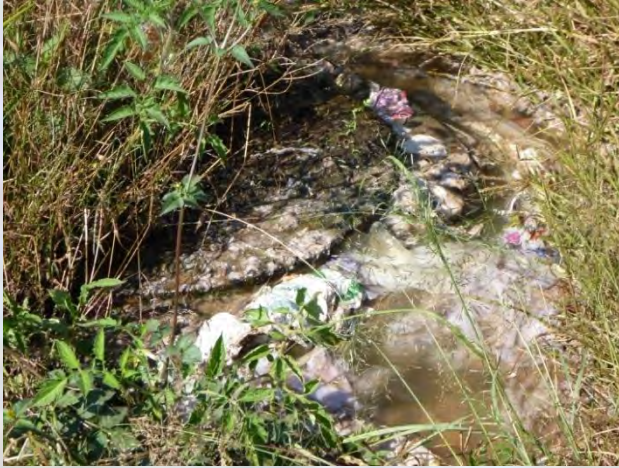
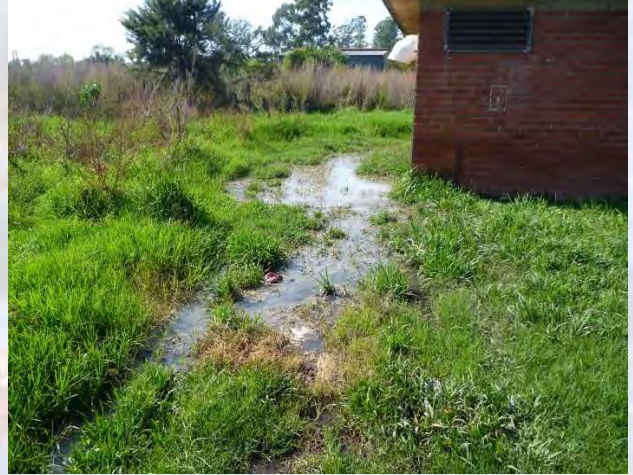
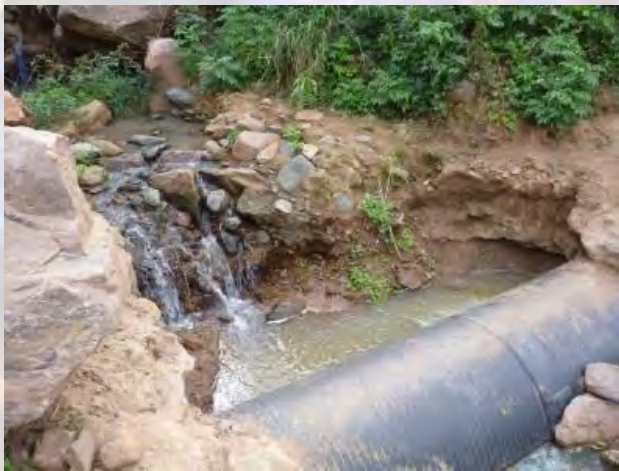
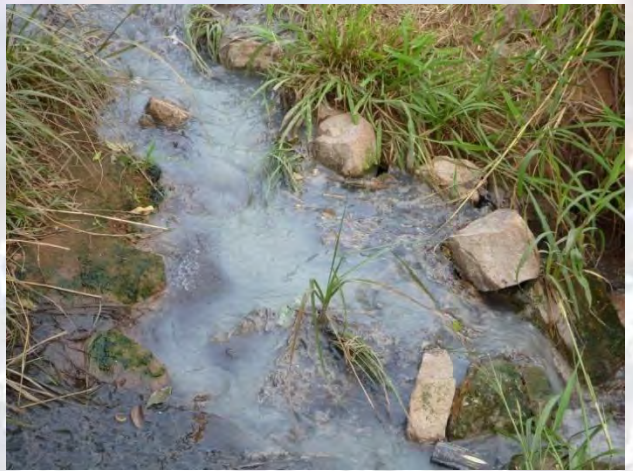
*Top right: Howick: Surcharging sewer pump station  
Middle right: Durban: Sewage stream en route to river*

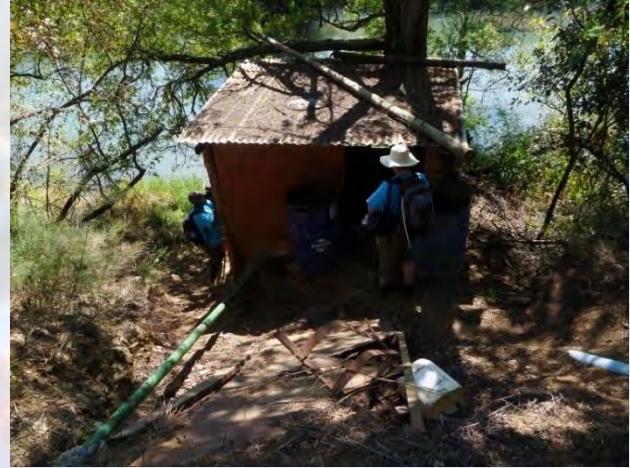
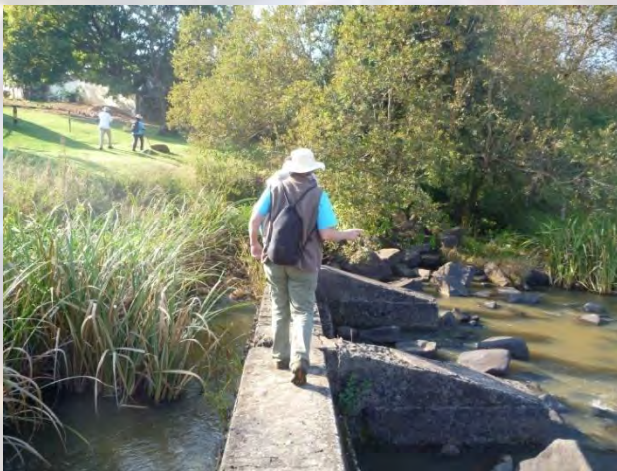
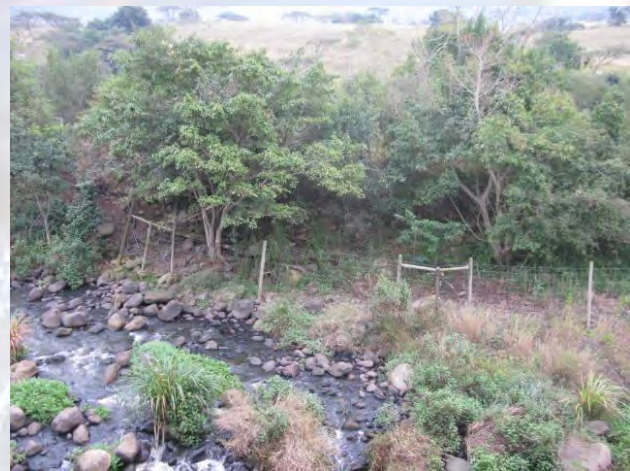
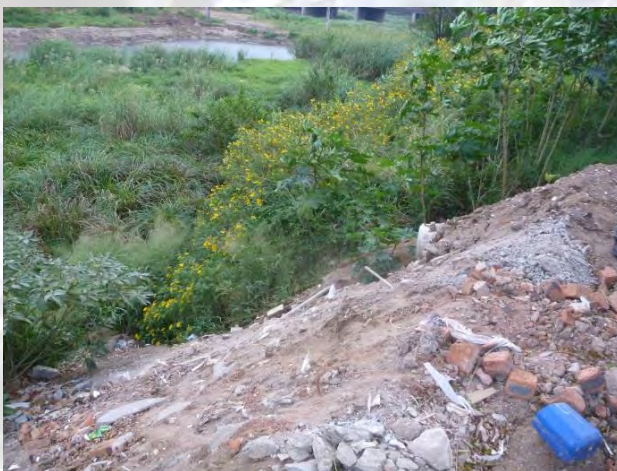
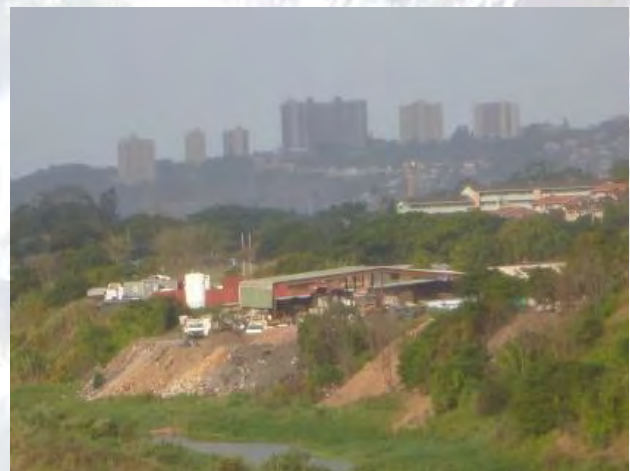
*Top left: Dargle: Fenced off river  
Middle left: Howick: Broken weir  
Bottom left: Durban: Illegal backfilling into river bed*
