**Report on Fieldwork to Map out Quarrying activities and Recently Graded  
Roads around Lake Ol Bolossat**

**Prepared By:  
Mildred Menda  
Jabes Okumu**

*February, 2017*

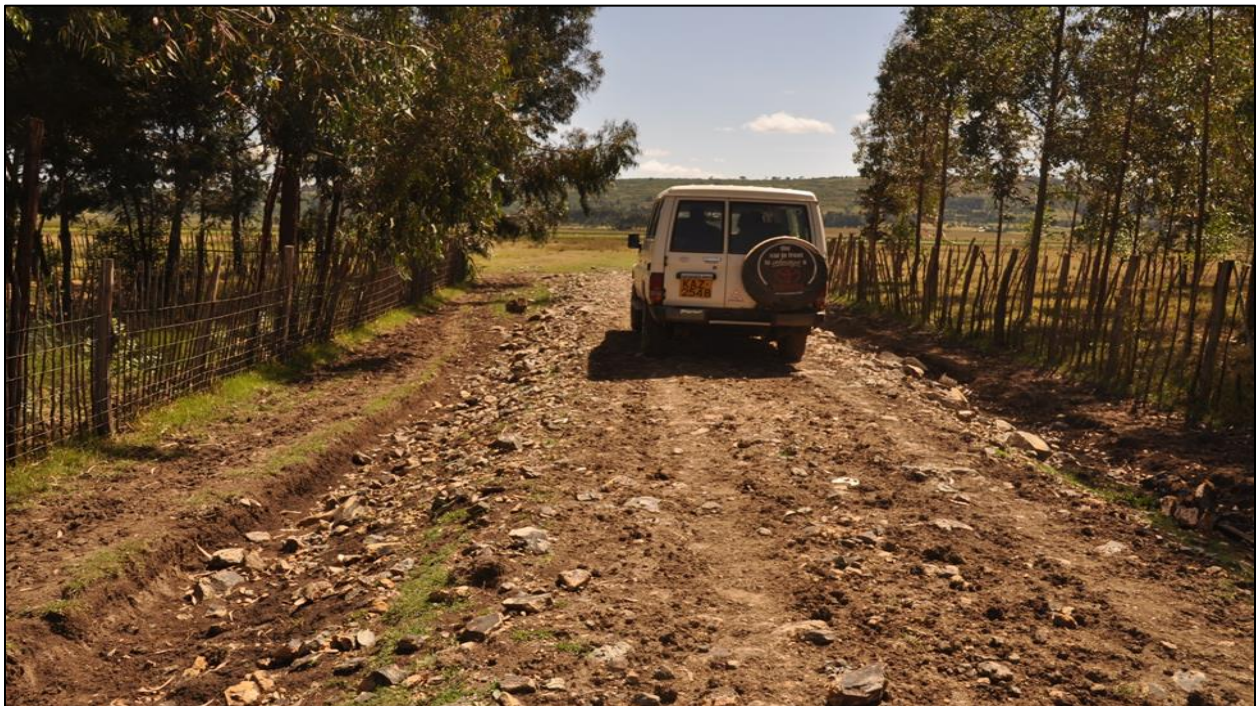
It is the mandate of the County Government under the ministry of public works, roads and transport to create access roads that connect the communities to the town centre to help them ferry their farm produce to market destinations. Recently, the County Government of Nyandarua funded the grading of a number of access roads connecting the communities, and to enhance access to the lake such as Figure 1 below.

*Figure 1: Recently graded road with loose pebbles on the surface. PHOTO Courtesy of EAWLS. 26/10/2016*

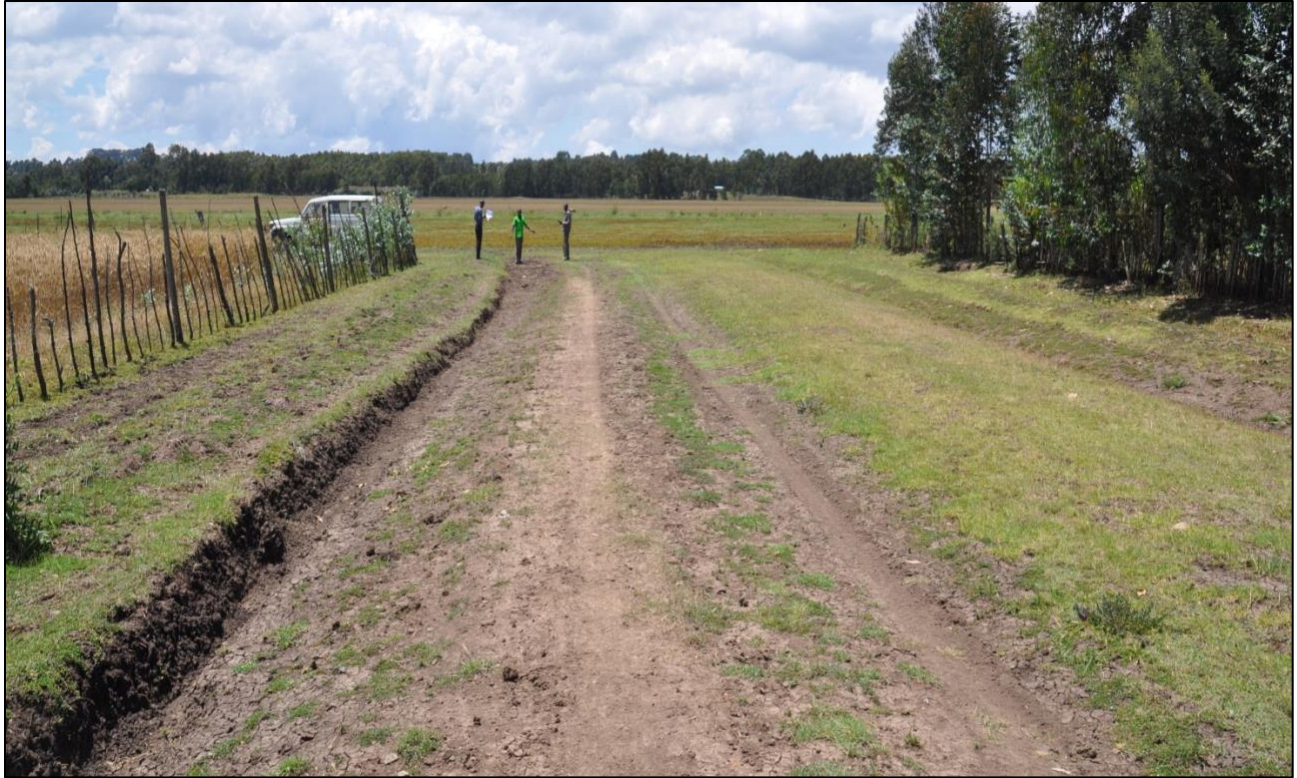
The road side drainage system of all the roads mapped was channeled into the lake with no environmental safeguards put in place (Figure 2). This has contributed significantly to siltation of the lake. The distance between the road end and the lake boundary was characterized by heaps of soil deposits making this buffer zones relatively flat full of grass. This is a very clear indication of the extent of siltation of the lake. Siltation causes receding water levels in the lake affecting directly on the aquatic life.

*Figure 2: A recently graded road ending on the lake boundary. PHOTO courtesy of EAWLS. 25/10/2016*

- Closure of all illegally operating quarrying sites.
- Develop a joint monitoring plan for Lake Ol Bolossat.
- The County department of water, environment and natural resources, in consultation with NEMA, should develop by-laws that guide infrastructural development such as roads within the county.

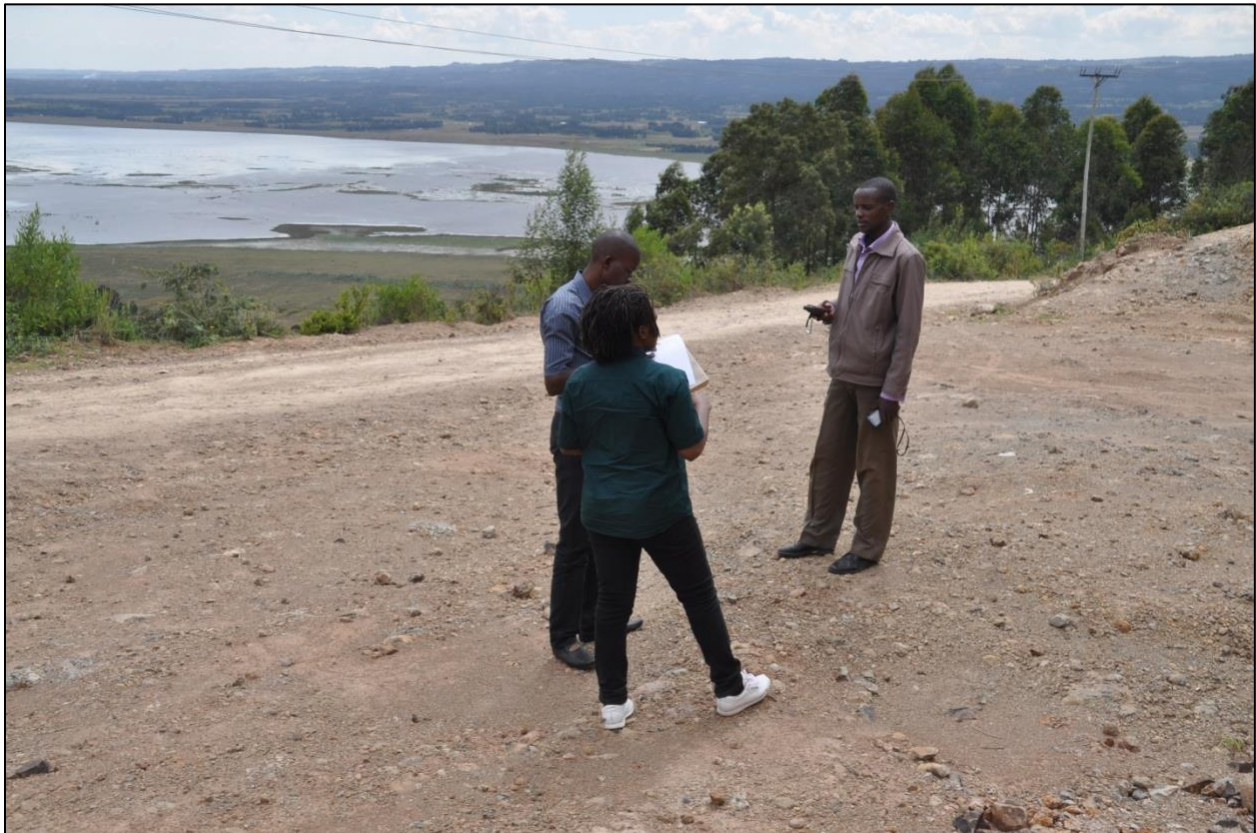
Three of these quarries touches on the lake boundary causing direct siltation. In addition, no decommission is conducted in any of these quarries and therefore loose soil deposits are left in heaps which are carried into the lake when it rains.

No safeguards have been put in place to prevent siltation (Figure 3) except one quarry site which is privately owned and is keenly monitored by NEMA. In this quarry site, water is pumped out of the quarry peats to the staff houses during rainy season, thus minimizing the extent of siltation to the lake.

*Figure 3: Quarrying site (within Ndaragua forest) about 100m from the lake, and is along a road leading to the lake. PHOTO courtesy of EAWLS. 25/10/2016.*

- NEMA should ensure strict monitoring of all the quarrying activities to ensure strict adherence to environmental regulations.
- Develop a land use plan to guide activities around Lake Ol Bolossat.
