# uMngeni River Source to Sea Walk

30 April to 28 May 2012

Compiled by Penny Rees  
Duzi uMngeni Conservation Trust (DUCT)

July 2014

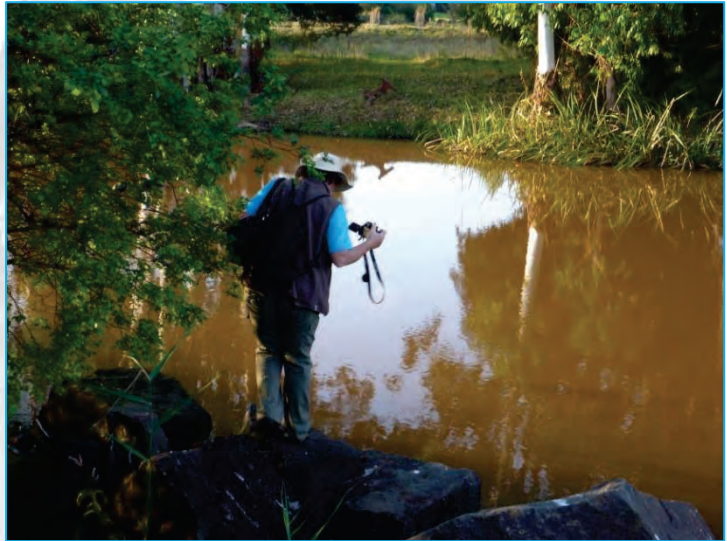
*Top: “Muddy” effect from turnover in Howick below Midmar Dam*

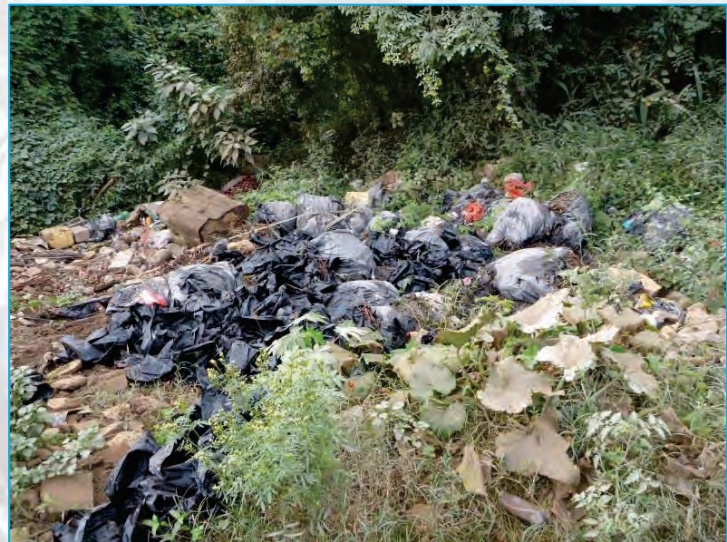
*Bottom: Illegal dumping, Howick*

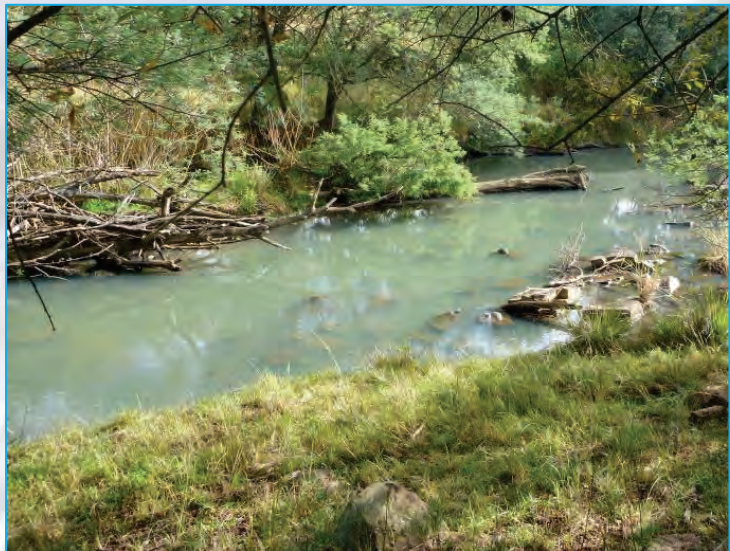
Top: Clear water, Upper Dargle  
Middle: Murky water in vicinity of poultry farms, Dargle  
Bottom: Watercress flourishing in Howick

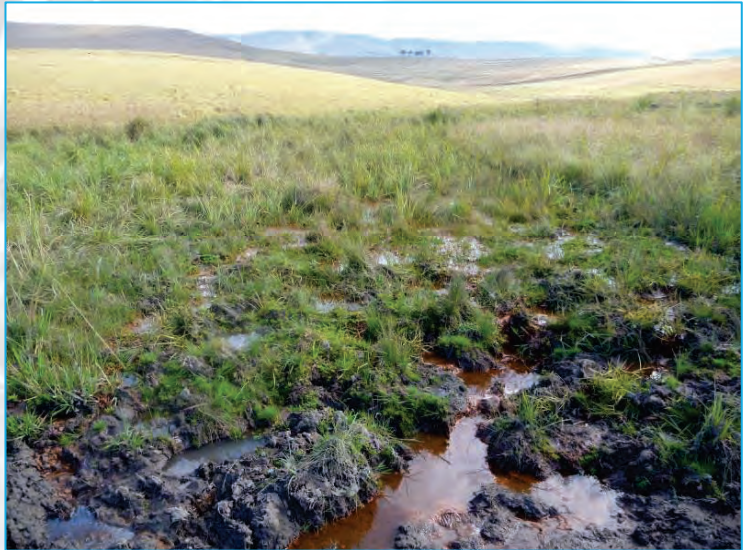
The main erosion impacts seen were cattle trampling wetlands and where they access the river to drink, old cattle paths, roads, disturbance or removal of river bank vegetation, overgrazing, silt from plantation areas and entering the river via the Lions River. (See Appendix 6.)

*Top: Wetland trampled by cattle*  
*Middle: Gully erosion – cattle access point*  
*Bottom: Heavy bramble infestation*

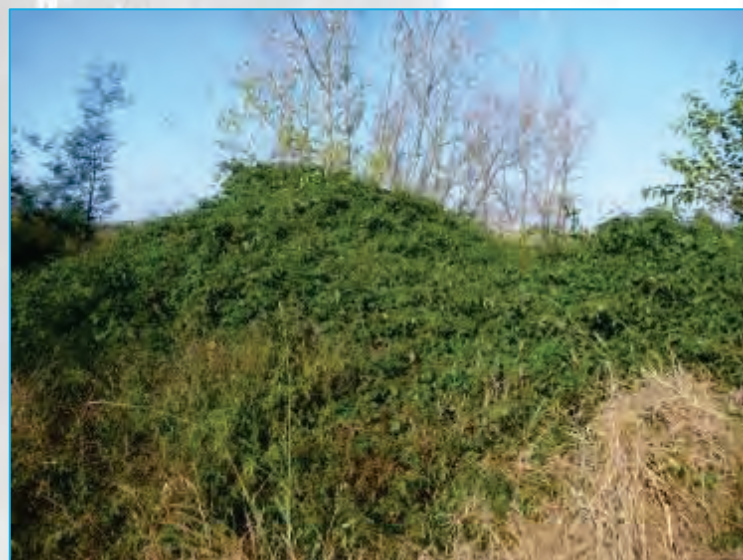
From this point down, most of the river to Midmar Dam is lined with Wattle and Bramble, the former comprising the dominant invasive plant in the area, followed by Bramble. They form an almost unbroken belt along the river, with Brambles occurring in large impenetrable bands parallel to the river.

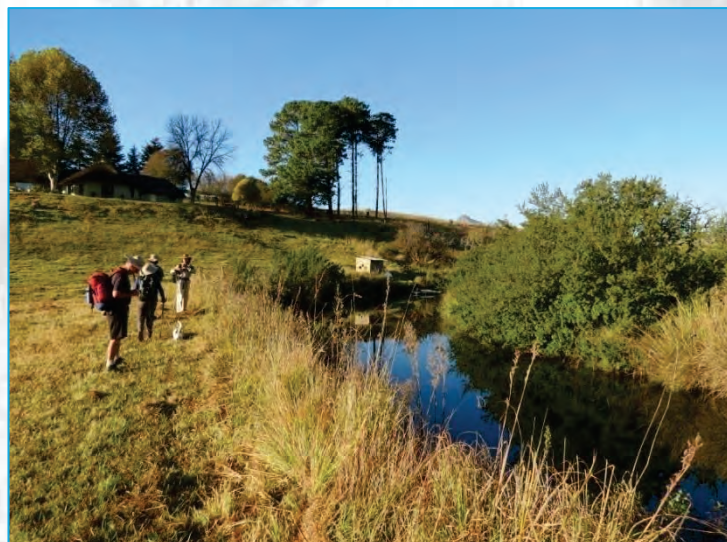
*Top: Clear water, Dargle*

*Middle: Turbid water: Lions /uMgeni Confluence*

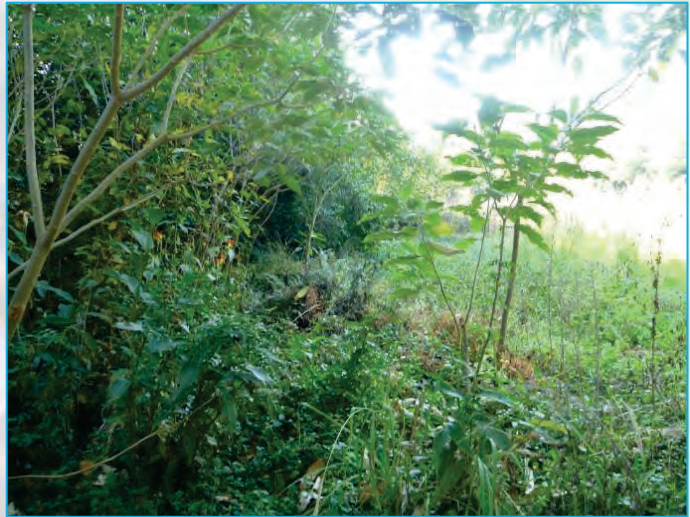
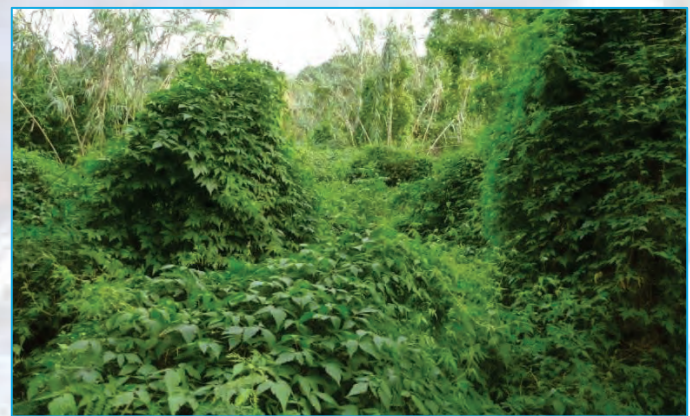
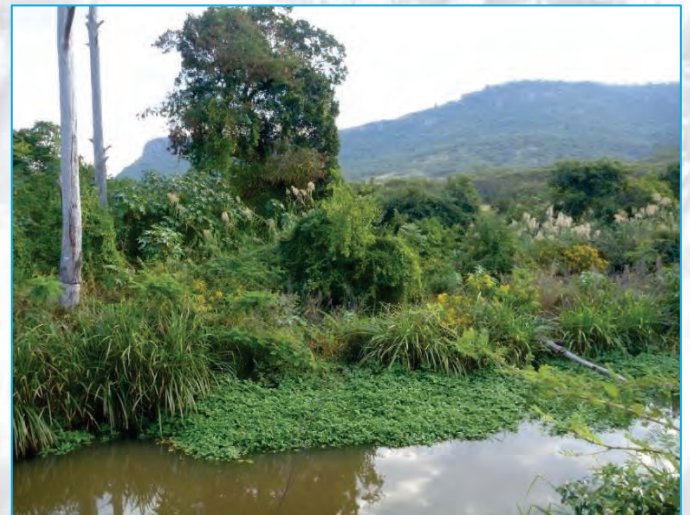
Approximately half of the forest in the gorge immediately below the Howick Falls is completely smothered by the invasive *Cardiospermum grandiflorum* (Balloon Vine), which is accompanied by light to medium infestations of an additional twenty two different species of invasive (there may be more, this is what we counted). This seems to be the downstream

Top: Invasives in riparian zone, Howick

Middle: Balloon Vine smothering indigenous forest in Howick Falls gorge

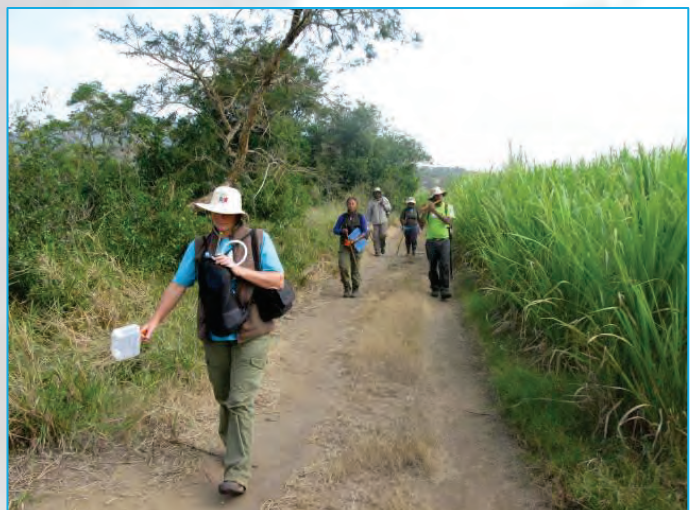
Sugar cane is planted within the buffer between Morton's Drift and Albert Falls Dam.

Right: Sugar Cane and road in buffer

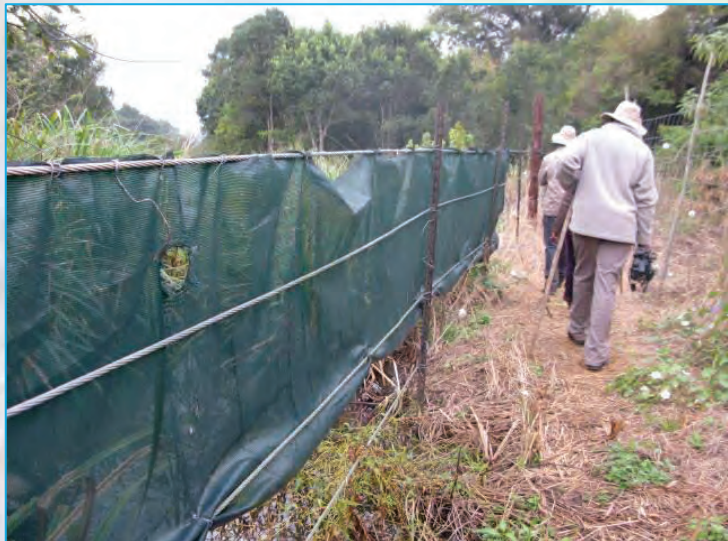
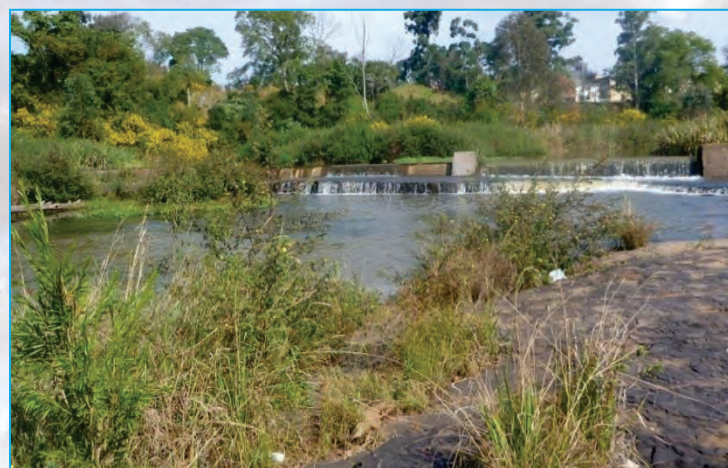
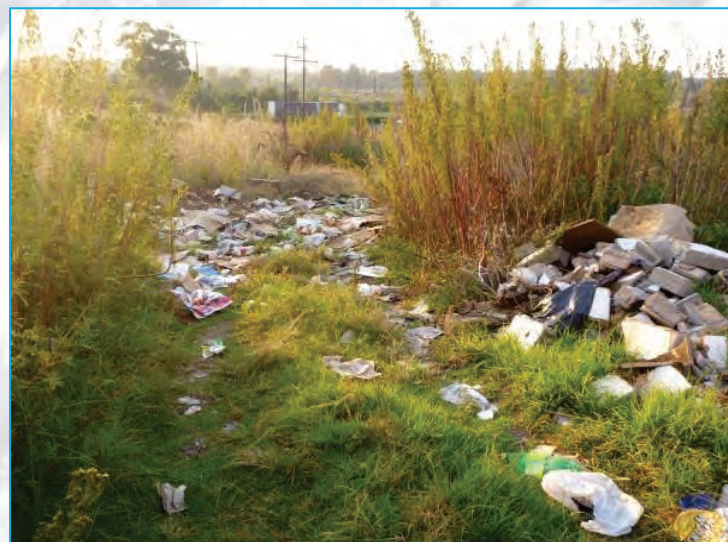
Between Midmar Wall and Howick we passed the first illegal dumping ground, next to the road below Midmar Dam with a well-worn access road: building rubble, cardboard, vehicle parts, general rubbish.

*Top: Impregnable game fence  
Middle: Weir above Howick Falls  
Bottom: Illegal dumping, Howick*

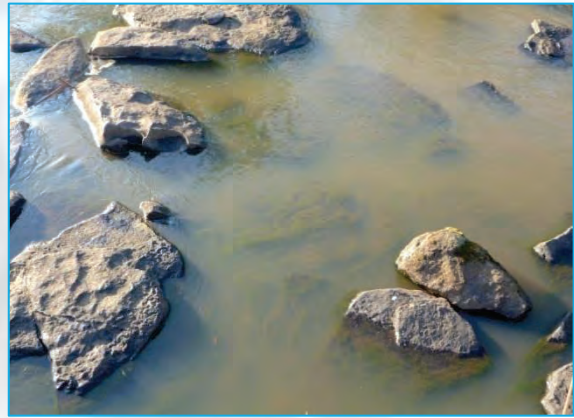
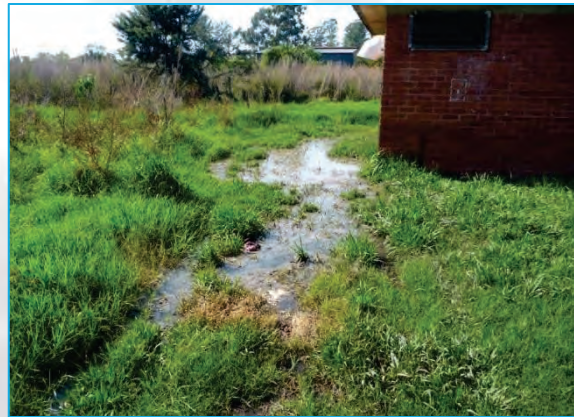
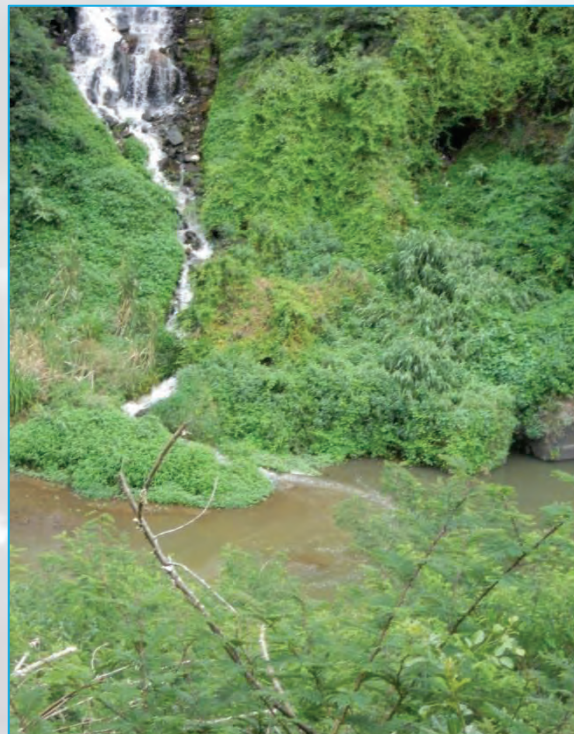
Algae was noted on rocks in various places through Howick and the first *Nasturtium officinale* (Watercress) was seen above the Howick Falls. A profusion of algal “sludge” was seen on the rocks below the Howick Falls. This disappeared upstream of the hydroelectric station and reappeared downstream of the WWTW outlet as well as an increased profusion of watercress. In addition to the above, sewer spills from overflowing sewer pump stations impact the river, along with possible contamination of storm water drains from the light industrial area.

Top: Turbid water and algae, Howick  
Middle: Surcharge – KwaMevana Sewage pump station  
Bottom: Howick Waste Water Treatment works effluent

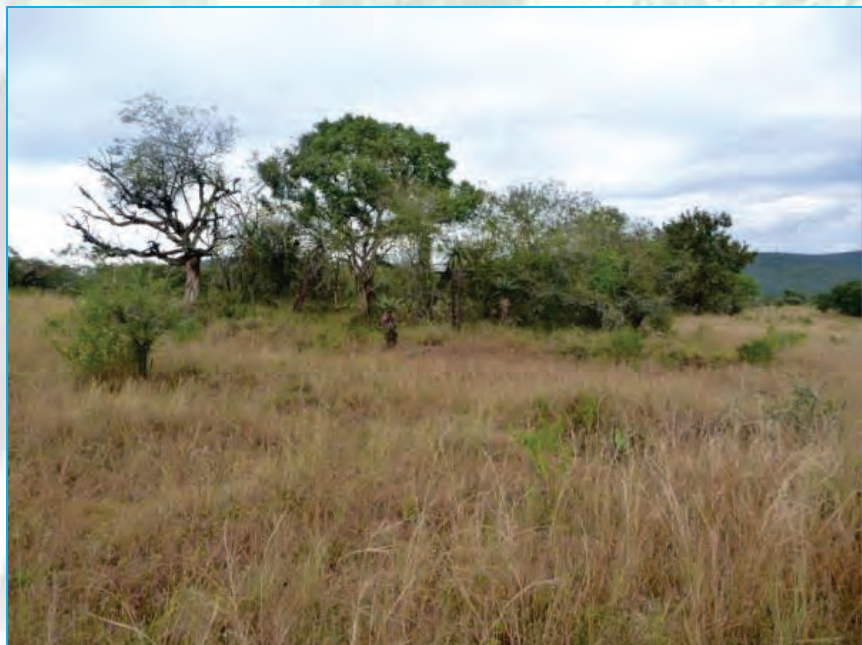
*Right: Rehabilitated sand mine, Cumberland*

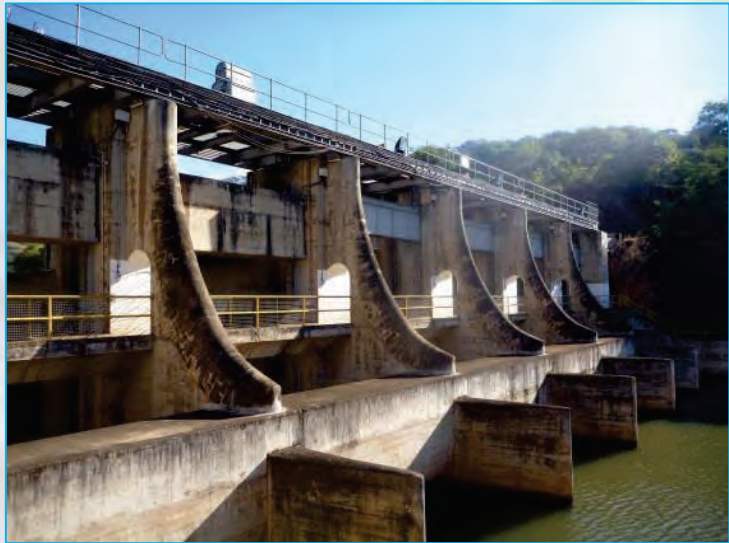
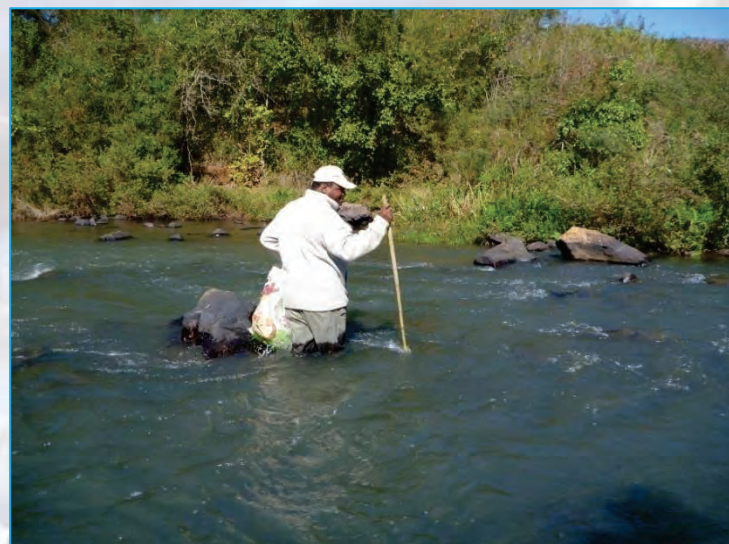
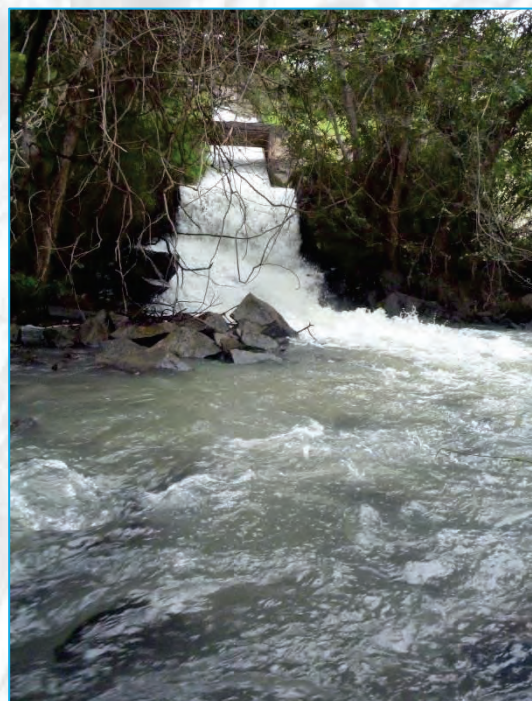
*Bottom: The only water released into the river from Nagle Dam*

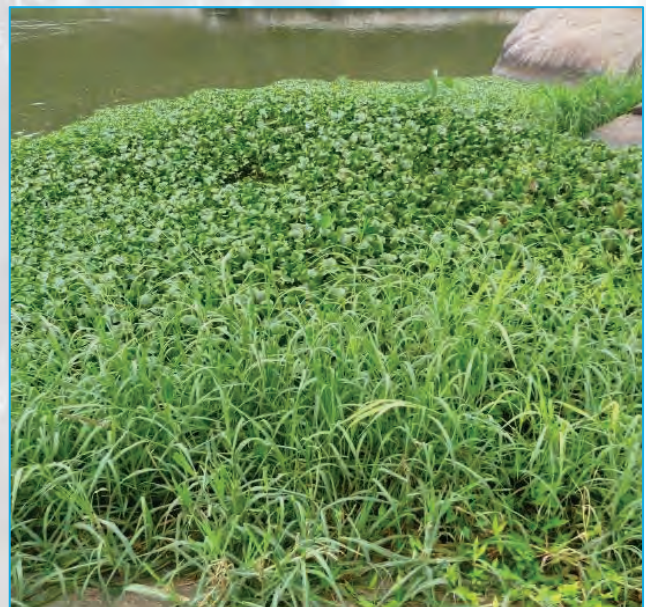
Bottom: Water hyacinth

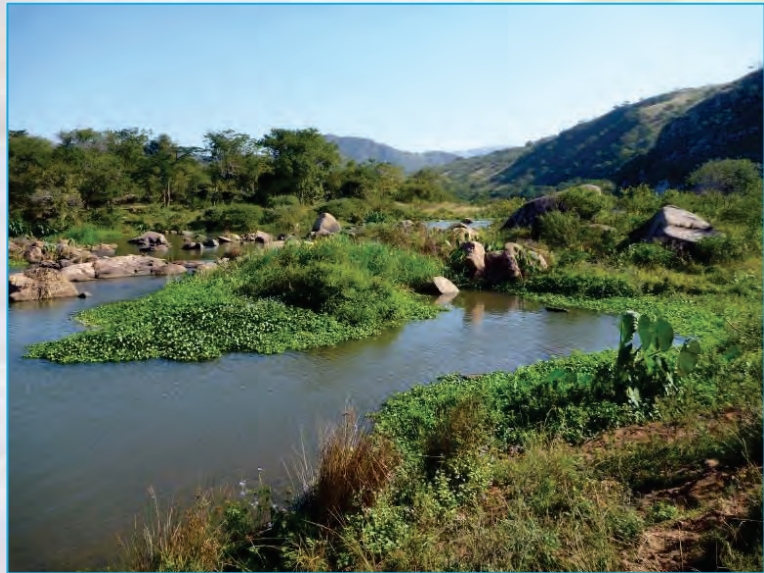
*Top: Water Hyacinth upstream of Inanda Dam*

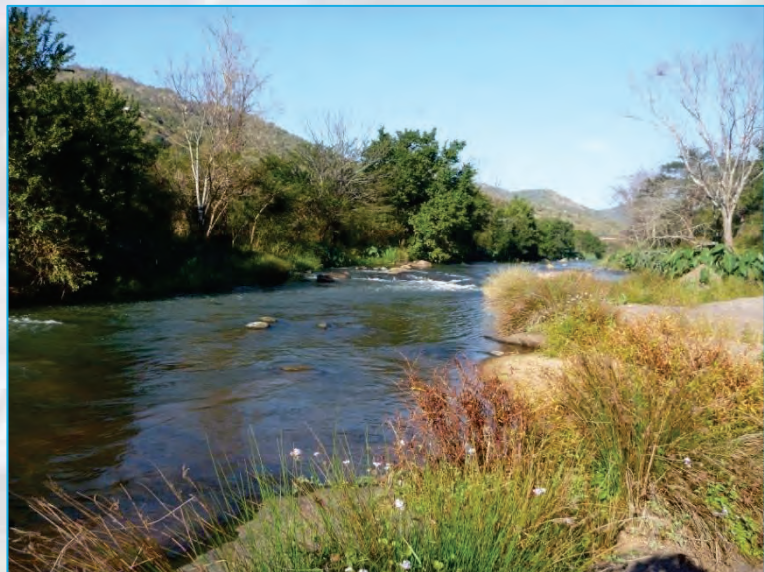
*Bottom: The second healthiest stretch of the entire uMngeni River, near Mfula Store*

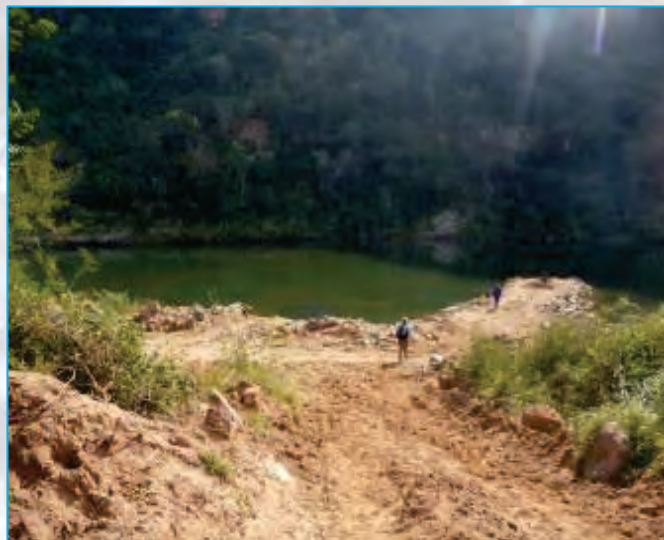
Some businesses adjacent to the river have illegally extended their properties by backfilling the river banks with what looks like landfill rubbish. The toe of these fills is on the edge of the river, and no doubt, under flood conditions, this will be washed away.

*Top: Illegal backfilling into river*

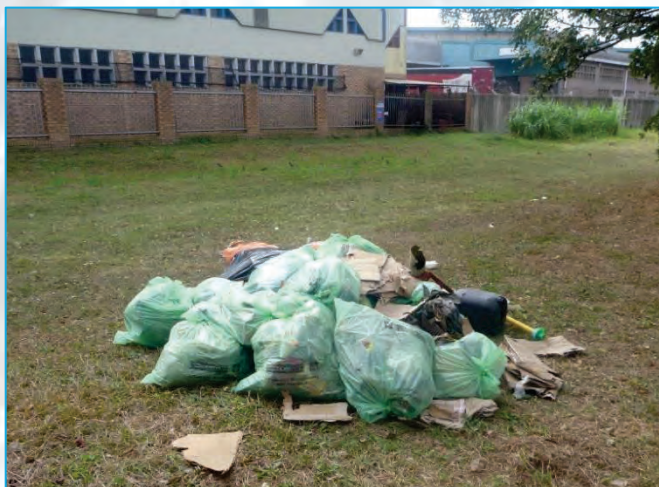
A large amount of litter is picked up on a daily basis by the DUCT River Care Teams whilst they are working alongside the river. Between the SPCA and Connaught Bridge, 500 bags were collected in one day recently, from car parts to garden waste and general rubbish. Prior to the 2012 Dusi canoe race 2 200 bags of rubbish were collected and removed by DUCT from the Blue Lagoon area.

*Top: A day's litter collection by DUCT River Care Team, Springfield Park  
Bottom: Engine oil and litter in storm water drain*

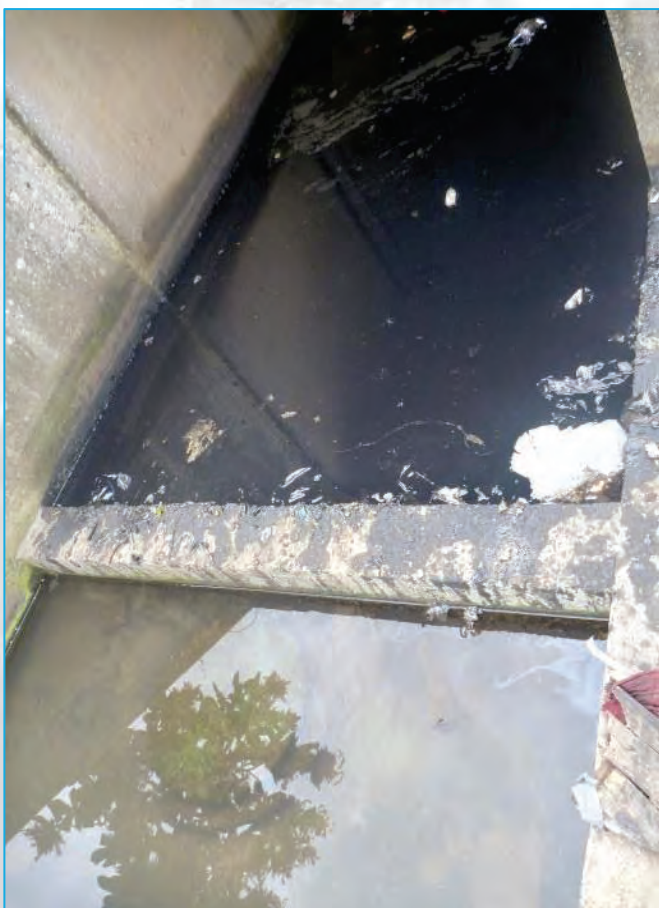
In the industrial area around Springfield Park most storm water drains were depositing litter into the river, and we were informed by the beach clean-up teams that we spoke to that during periods of heavy rains, the river is filled with plastic rubbish which is then deposited on the beaches. Apparently from the air during floods, the litter looks like thousands of plastic streamers entering the ocean. DUCT has erected a trash boom across a section of Blue Lagoon in an attempt to trap some of the rubbish. This is cleared regularly, however, during flooding events it is unlikely that this will be sufficient. (See Appendix 6.)

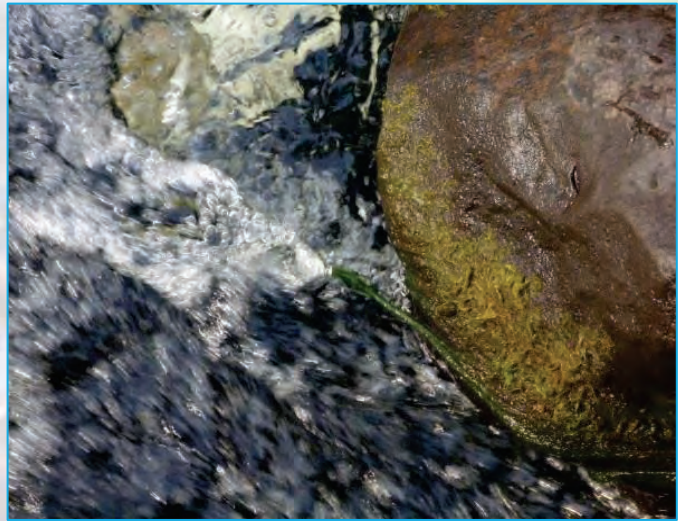
*Top: Algae and clear water below Inanda Dam*

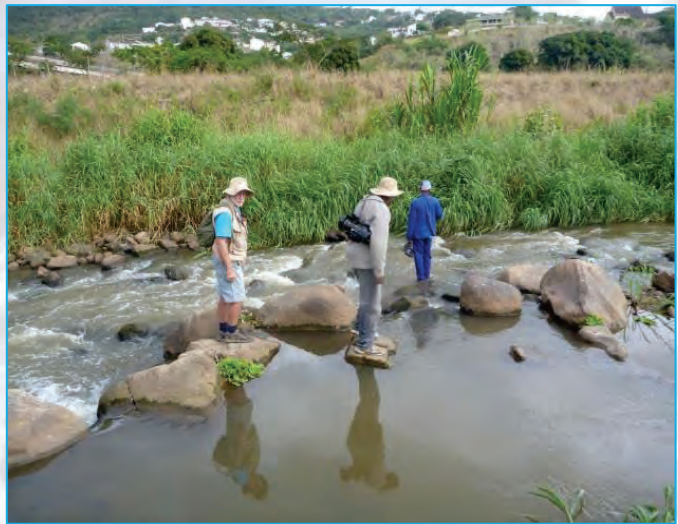
*Middle: River contaminated with sewage*

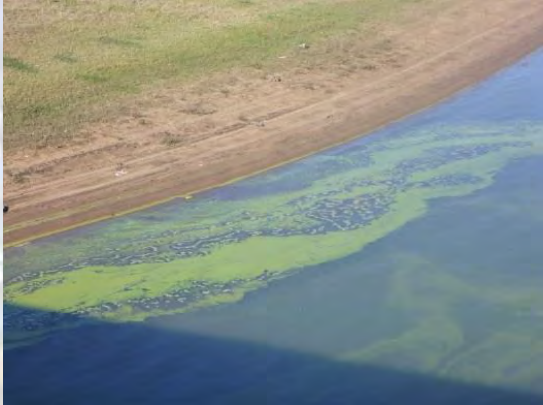
## Section 6: Nagle Dam

Algae inside silt weir

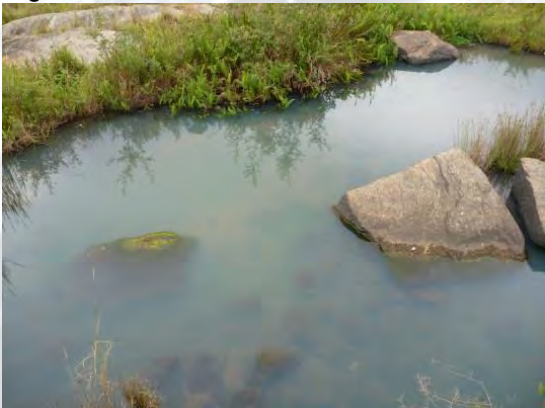
## 1st road bridge d/s of Nagle Dam Algae on rocks

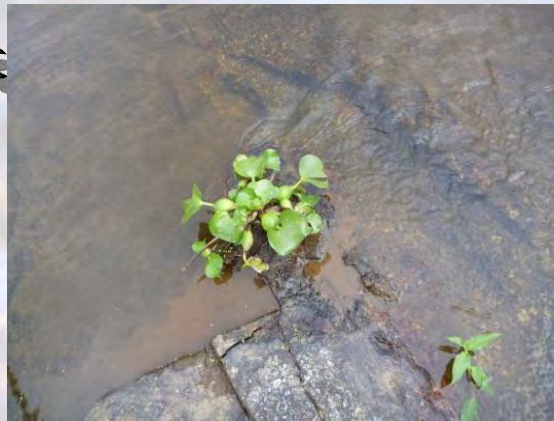
**1st *Eichornia crassipes* (Water Hyacinth)**

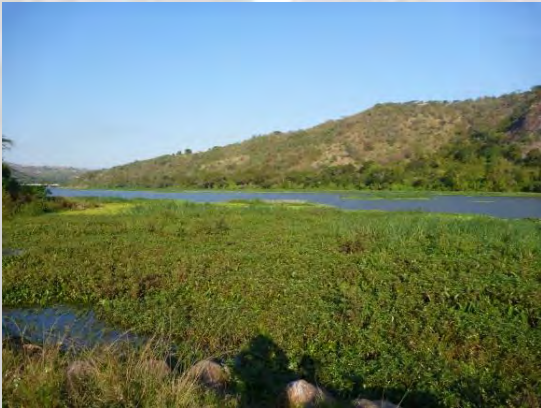
### Inanda Dam Inlet

Mass of various invasives

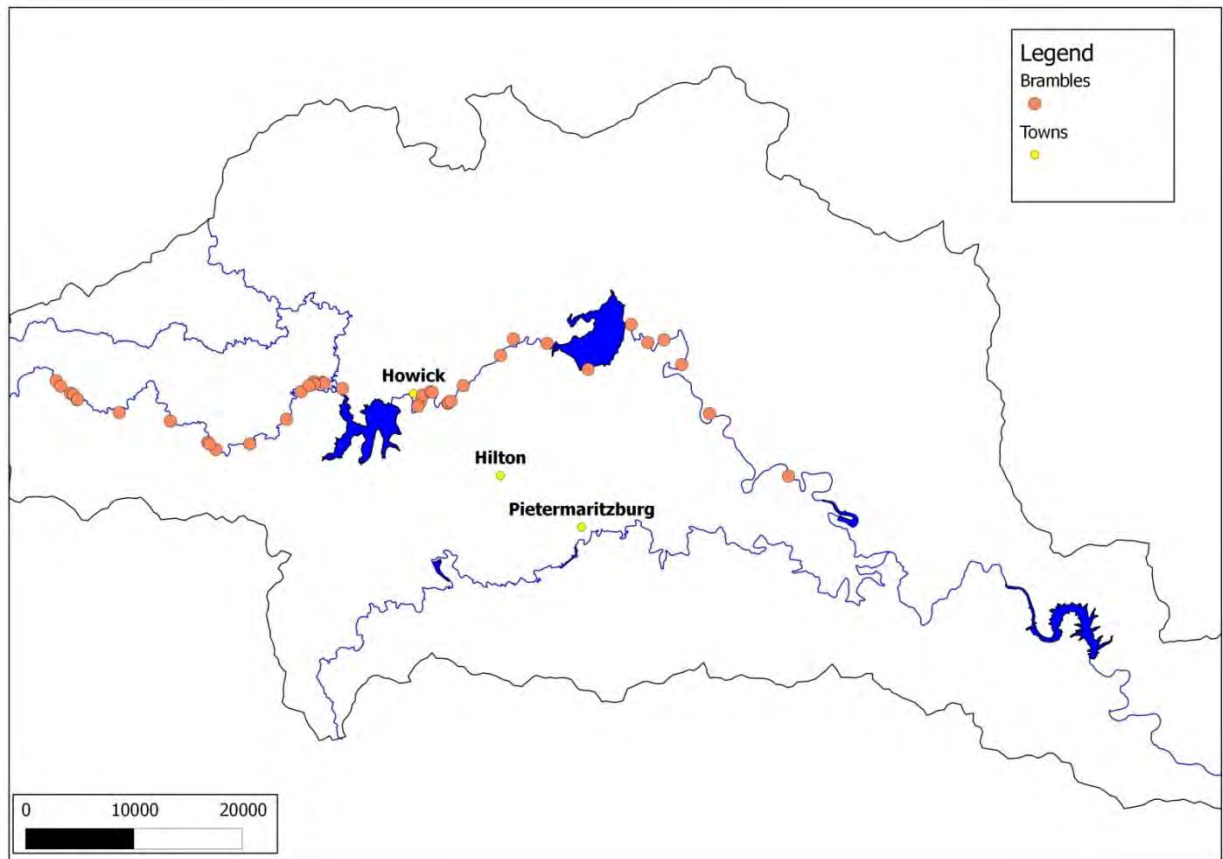
## Map: Areas of Heavy Bramble Infestation

Note: this map shows only the heavy infestations of bramble seen along the river and does not account for the light and medium infestations

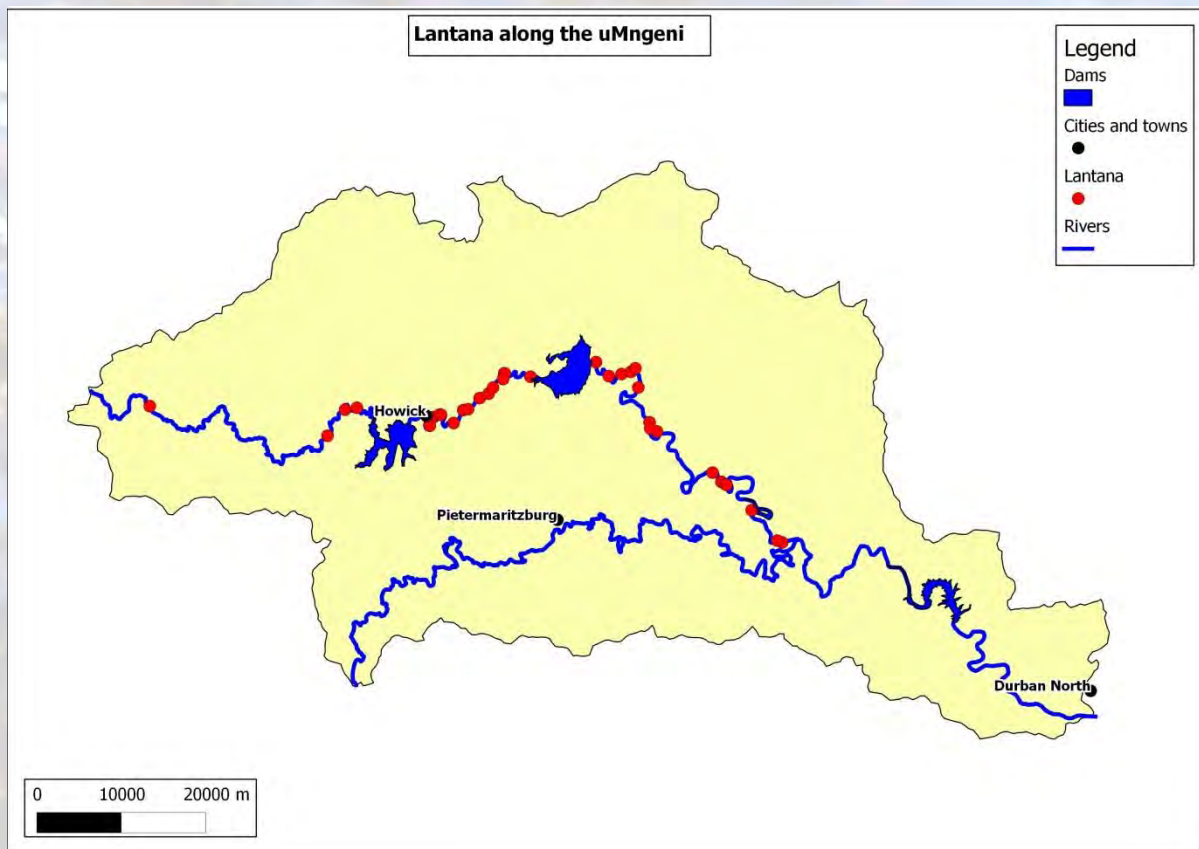
## Map: Areas of Heavy Lantana Infestation

Note: this map shows only the heavy infestations of lantana seen along the river and does not account for the light and medium infestations.  
The first red dot on the map is erroneous, as this was a mistaken identity.

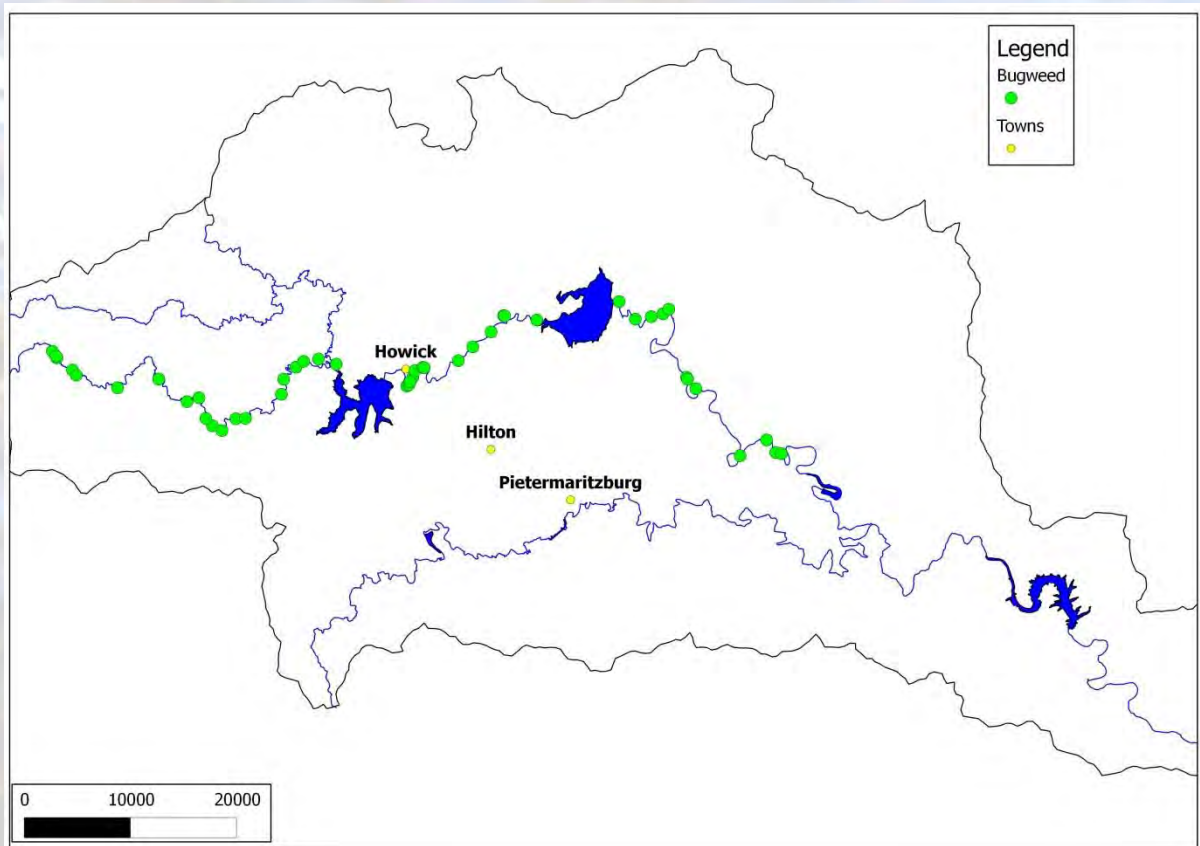
## Map: Areas of Heavy Bugweed Infestation

Note: this map shows only the heavy infestations of bugweed seen along the river and does not account for the light and medium infestations

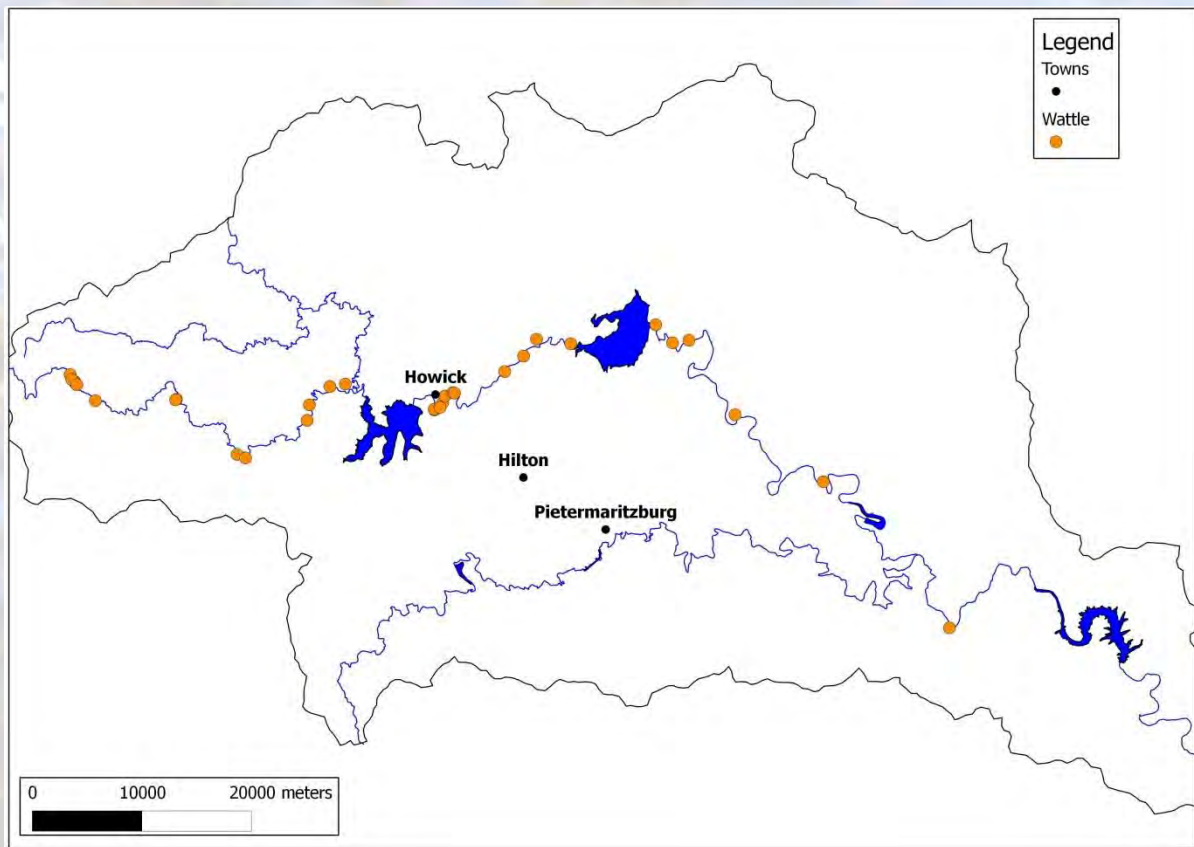
## Map: Areas of Heavy Wattle Infestation

Note: this map shows only the heavy infestations of bugweed seen along the river and does not account for the light and medium infestations

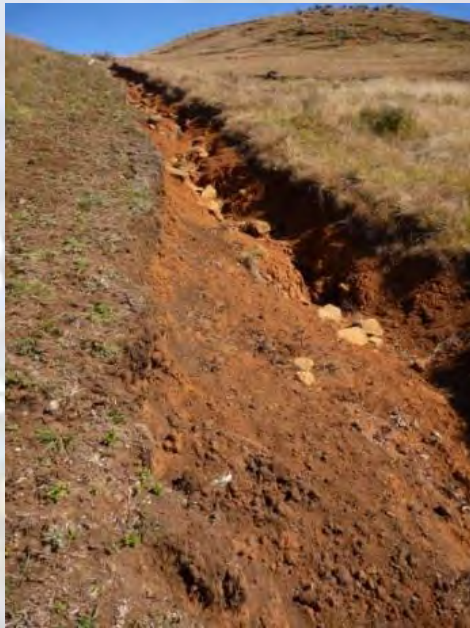
*Top left: Source plateau: Old Road  
Middle left: Upper catchment: Bulldozing of river bank  
Bottom left: Upper catchment: Bulldozing of floodplain*

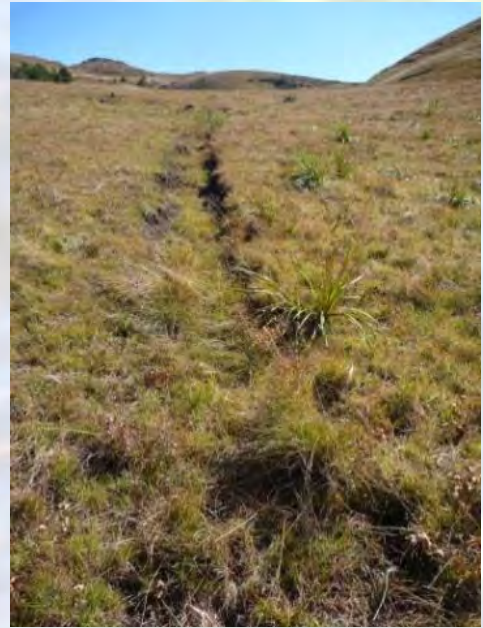
*Top right: Source plateau: Old Cattle Path  
Middle right: Upper catchment: Bulldozing of river crossing  
Bottom right: Dargle: Wetland trampled by cattle*

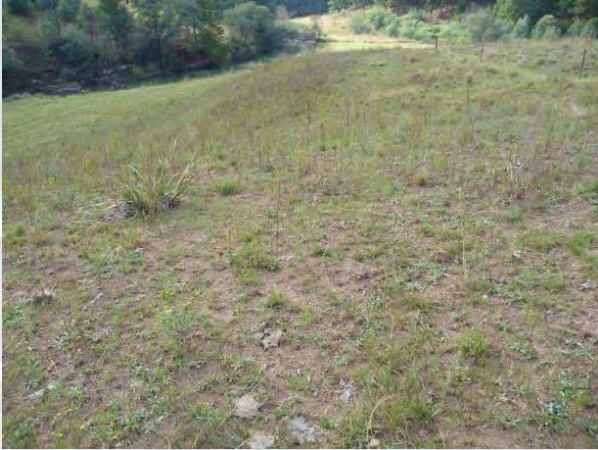
*Top left: Dargle: Overgrazing  
Middle left: Dargle: River banks trampled by cattle  
Bottom left: Dargle: Overgrazing*

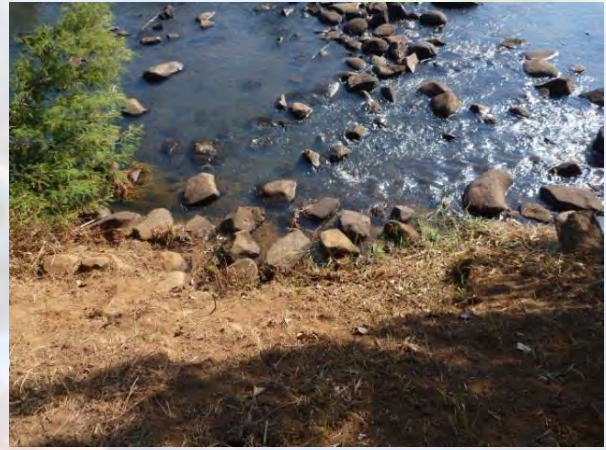
*Top right: Dargle: Cleared steep river bank  
Middle right: Dargle: Fertilizer stains on rocks  
Bottom right: Dargle: Cattle access to water*

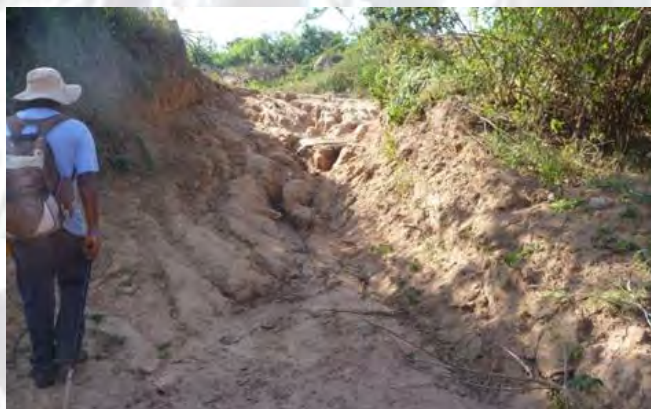
*Top right: Upstream of Albert Falls Dam: Gully erosion  
 Middle right: Downstream of Albert Falls: Soil erosion at pump house  
 Bottom right: Nagle Dam: Silt release channel*

*Top left: Albert Falls inlet: Fertilizer stains on rocks  
 Middle upper left: Nagle Dam: Sand bearing stream entering dam  
 Middle lower left: Durban: Near new KwaDabeka road bridge  
 Bottom left: Durban: Upstream of Molweni Cemetery*

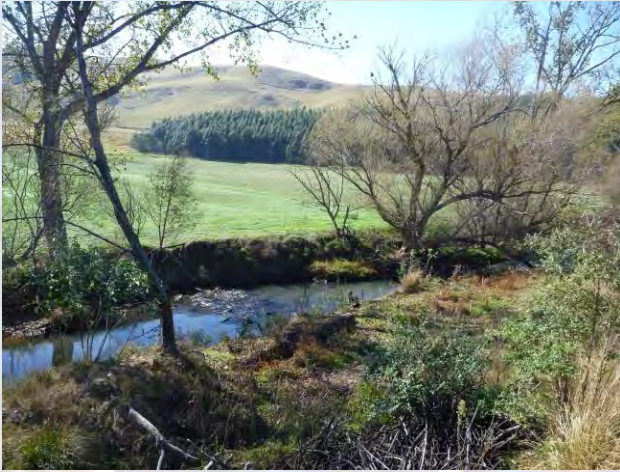
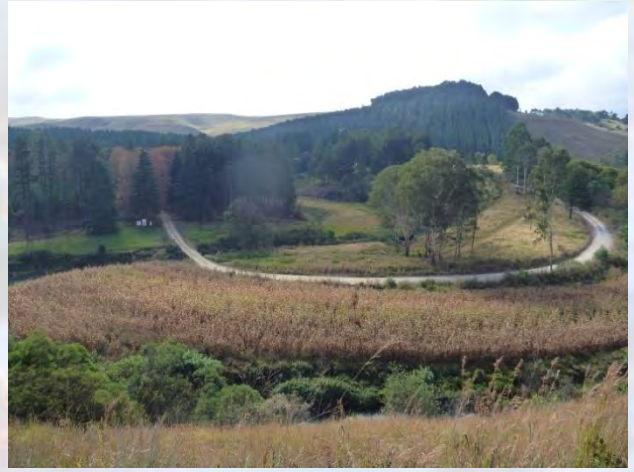
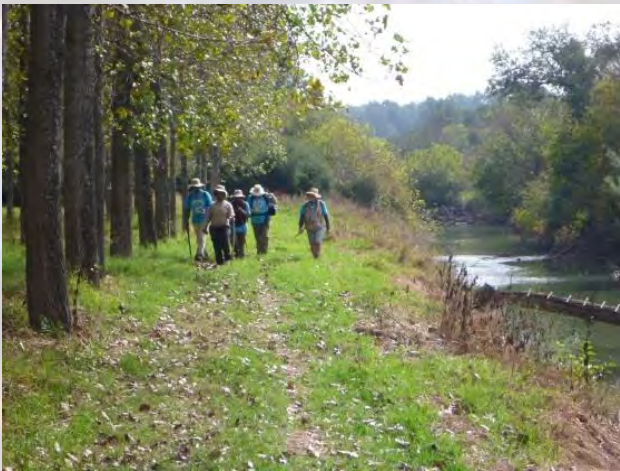
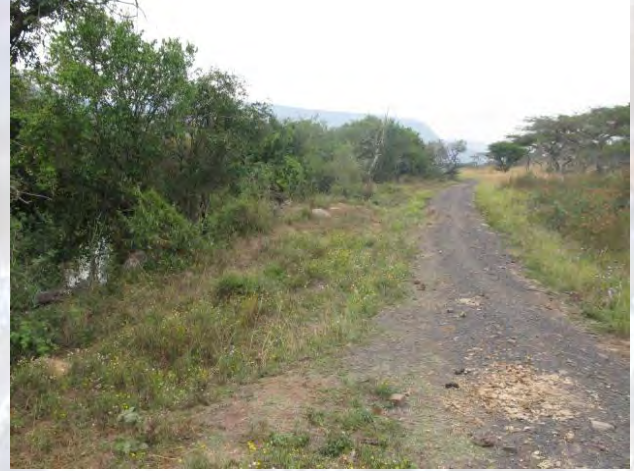
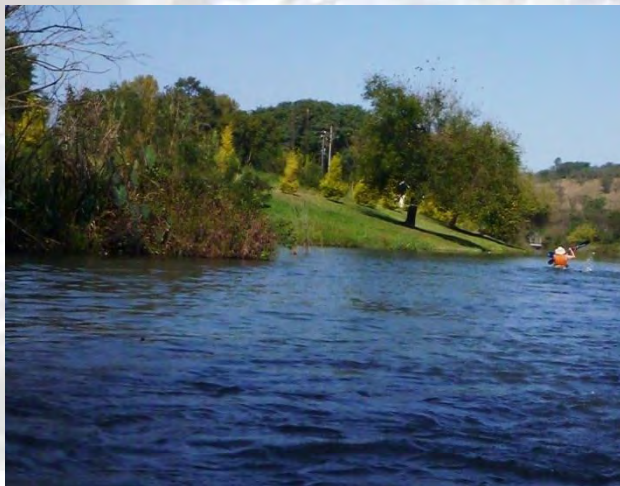
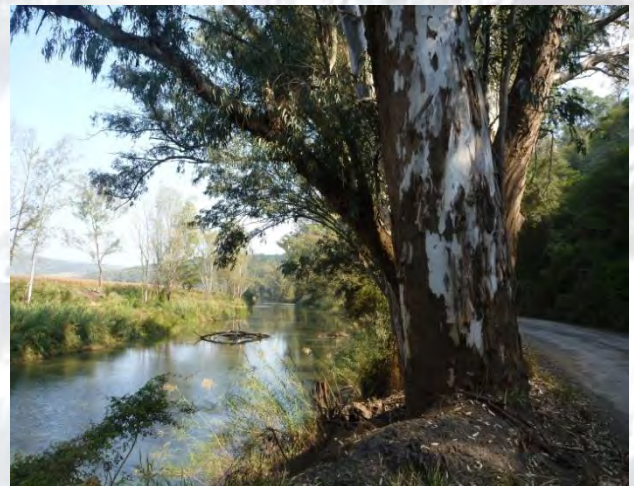
*Top left: Dargle: Rye grasslands  
Middle left: Dargle: Poplar grove and kikuyu  
pasture  
Bottom left: Albert Falls Village: gardens to  
water edge*

*Top right: Dargle: Maize lands  
Middle right: Upstream of Albert Falls Dam: Road  
Downstream of Albert Falls: District road*

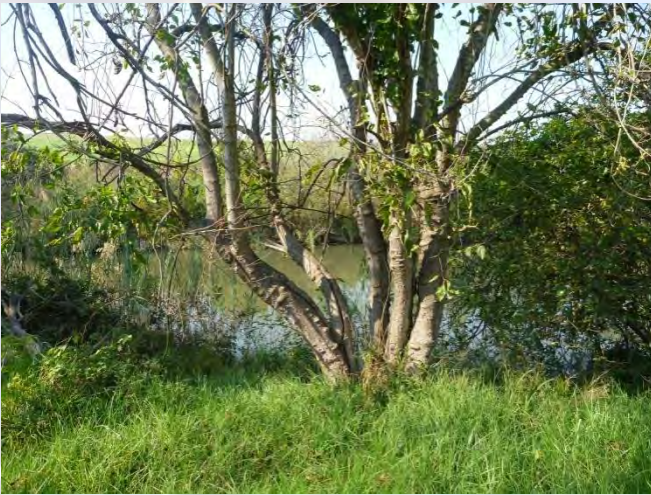
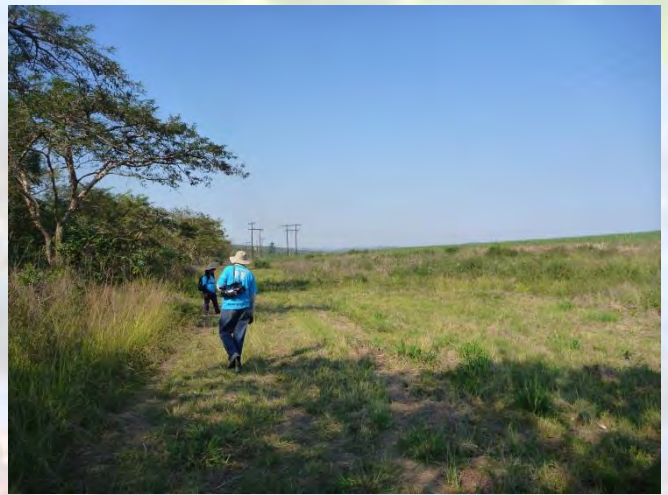
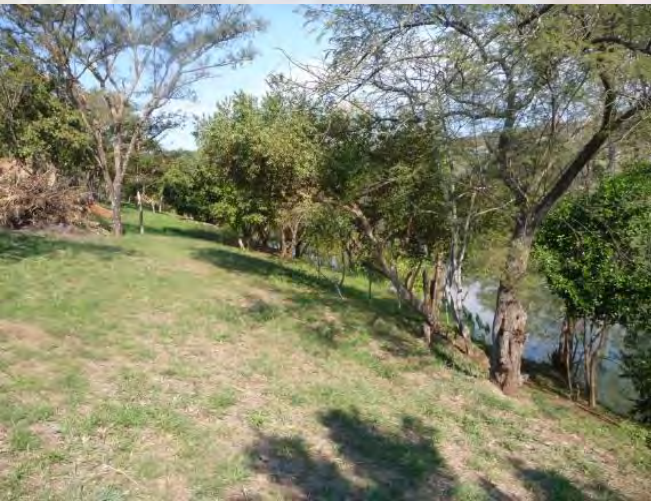
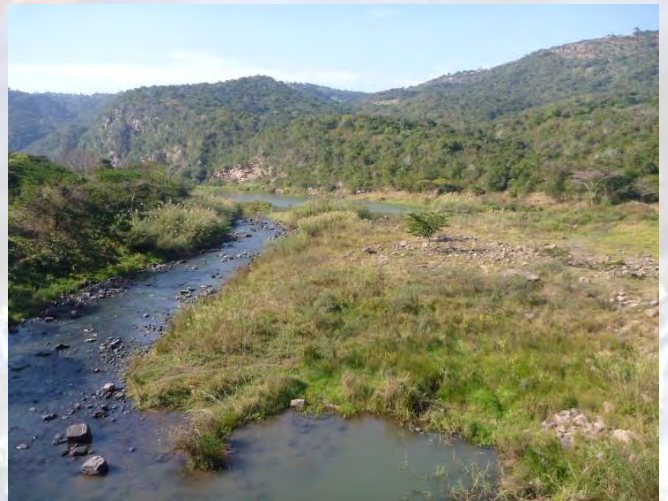
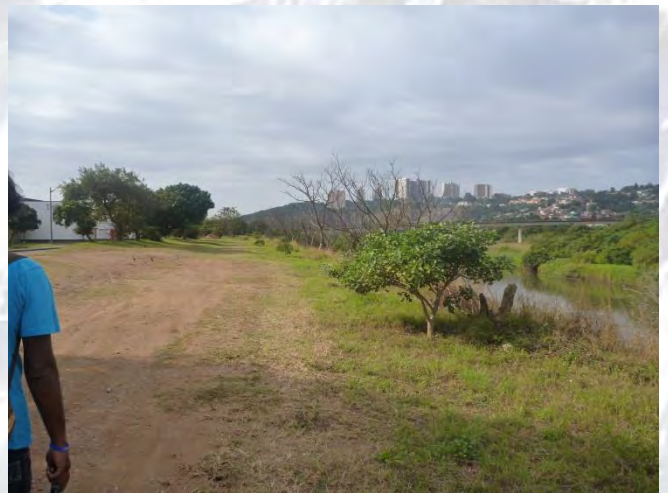
*Top left: Downstream of Albert Falls: Kikuyu  
Middle left: Downstream of Albert Falls: New garden  
Bottom left: Durban: Sand mining*

*Top right: Downstream of Albert Falls: Eskom servitude  
Middle right: Durban: Un-rehabilitated sand mine  
Bottom right: Durban: Industrial area*
