# uMngeni River Source to Sea Walk

30 April to 28 May 2012

Compiled by Penny Rees  
Duzi uMngeni Conservation Trust (DUCT)

July 2014

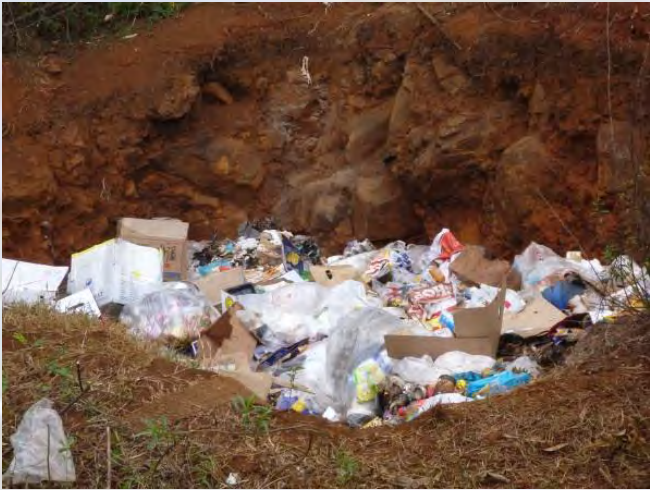
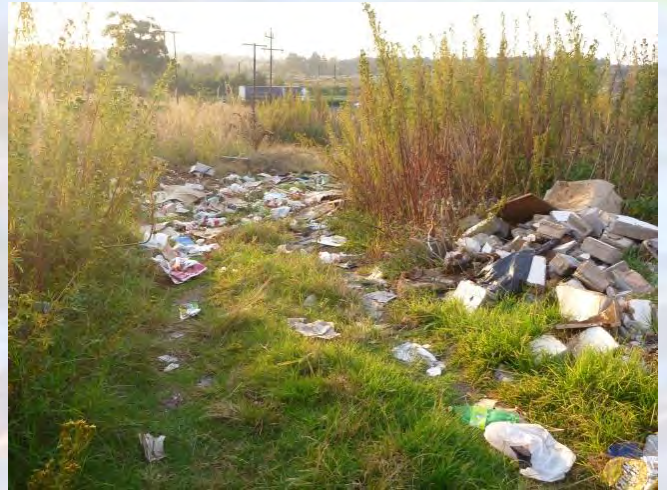
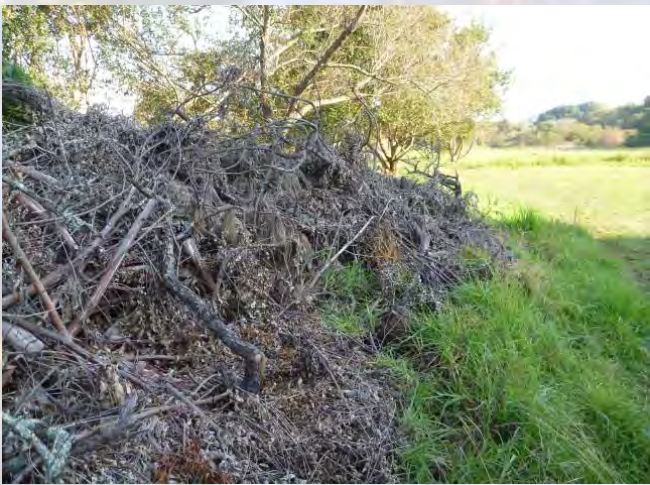
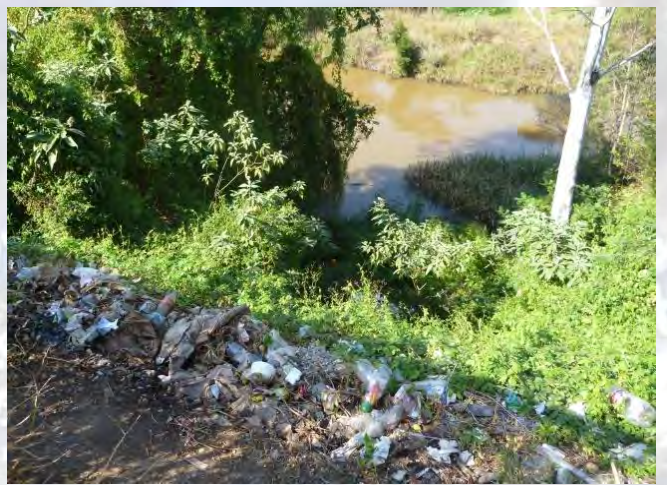
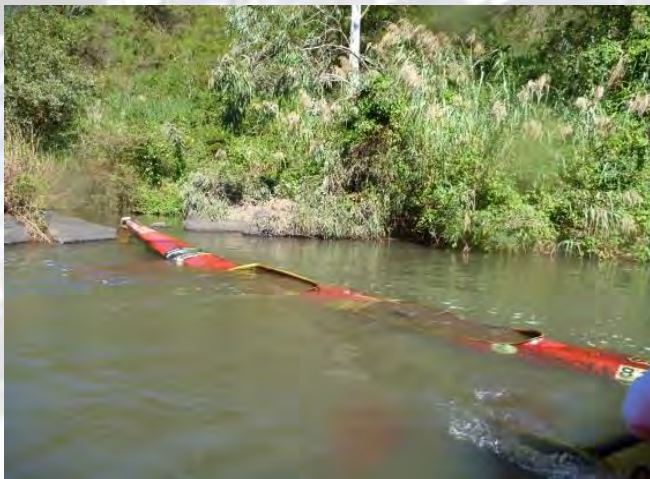
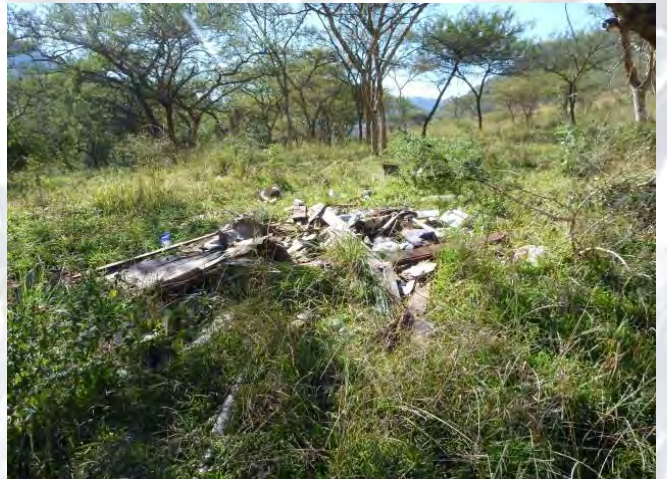
*Top left: Dargle: Rubbish pit  
Middle left: Howick: Garden rubbish  
Bottom left: Cumberland: Abandoned canoe*

*Top right: Howick outskirts: Dumping  
Middle right: Howick commercial area: Litter  
Bottom right: Upstream of Nagel Dam: Dumping*

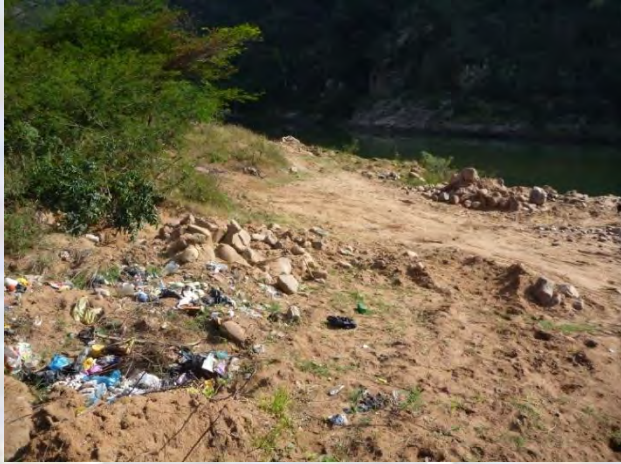
*Top right: Durban: Dumping  
Bottom right: Industrial area: Wind blown litter*

*Top left: Durban: Burnt rubbish at sand mine  
Middle left: Durban: Dumping  
Bottom left: Springfield Park: Litter collected by  
DUCT River Care Team*

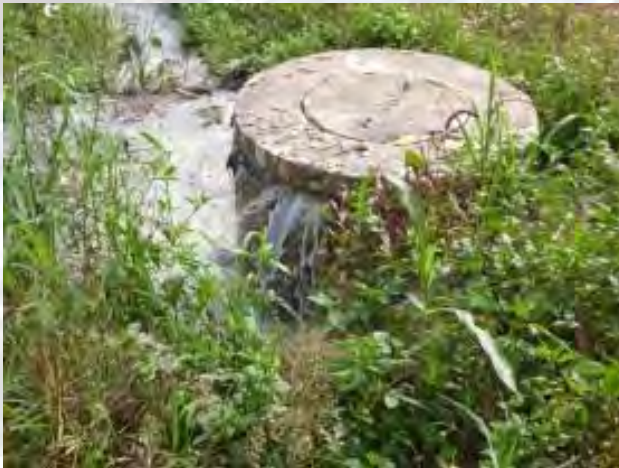
*Top right: Howick: Surcharging sewer pump station  
Middle right: Durban: Sewage stream en route to river*

*Top left: Howick: Surcharging manhole  
Middle left: Durban: Sewage stream en route to river  
Bottom left: Durban: Surcharging manhole*

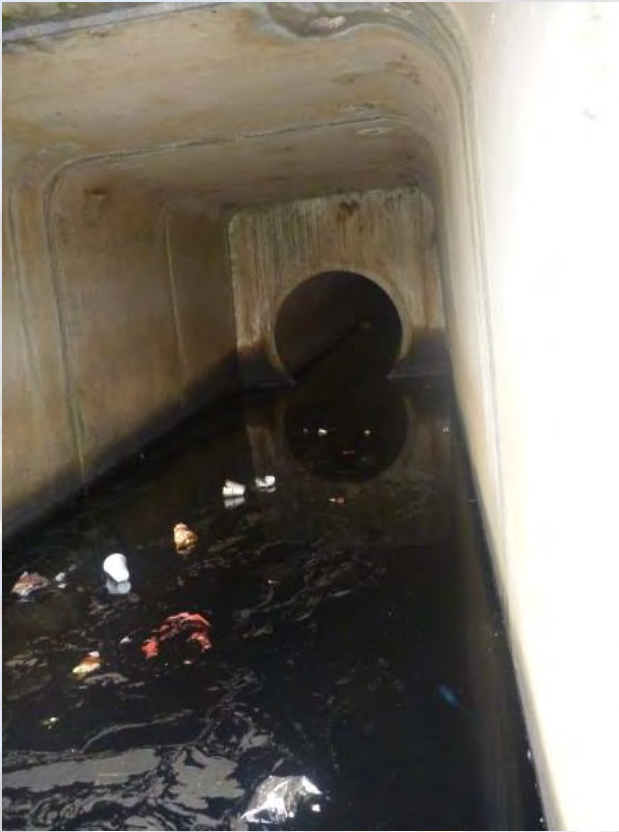
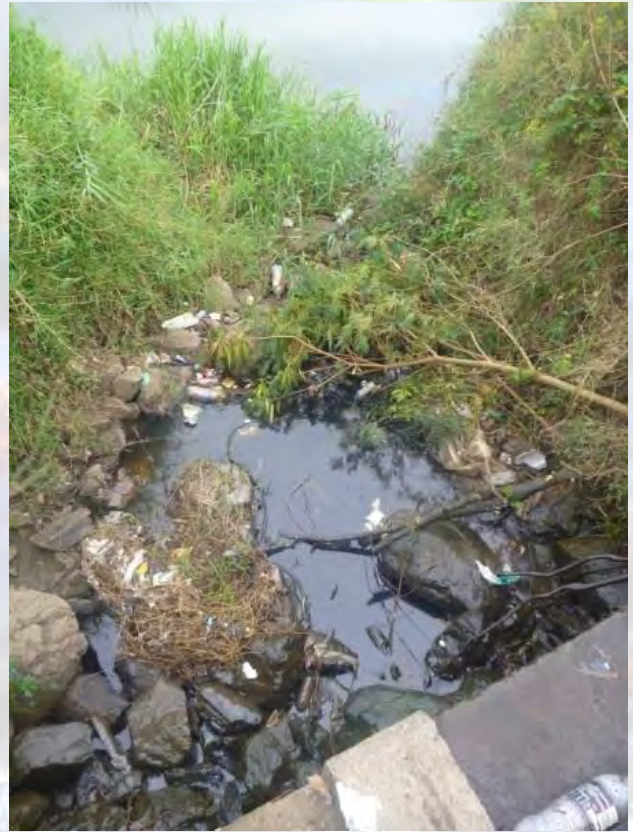
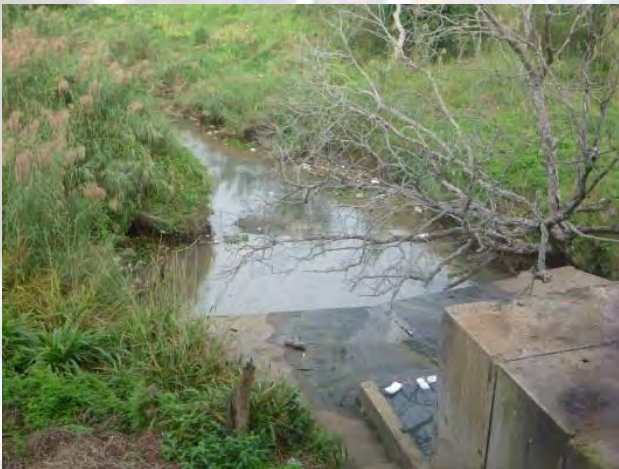
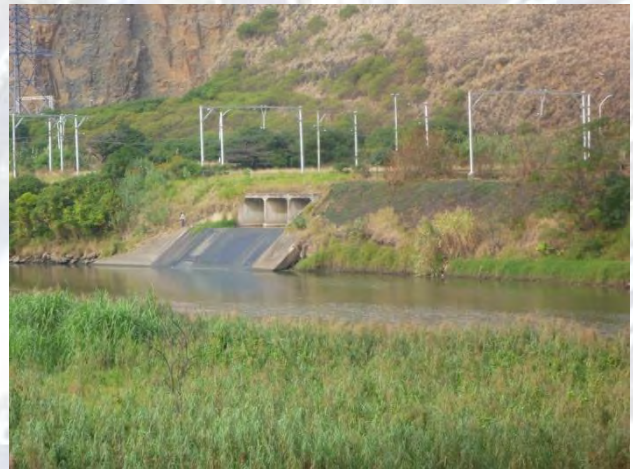
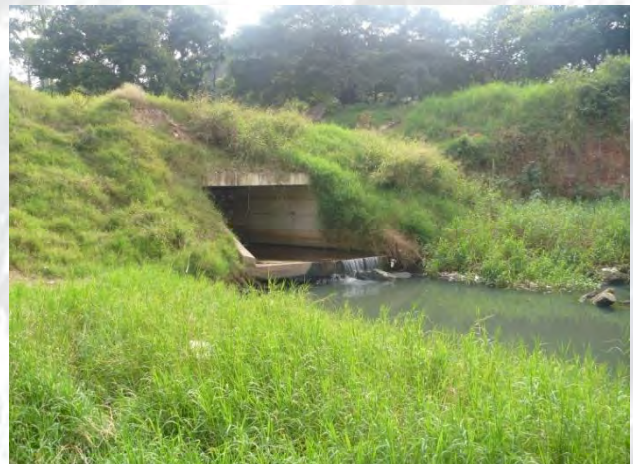
*Top left: Durban industrial area: Litter and engine oil  
Bottom left: Durban: Litter and oil  
Top right: Durban: Litter and engine oil  
Middle right: Durban  
Bottom right: Durban: Blue Lagoon (strong sewage smell)*

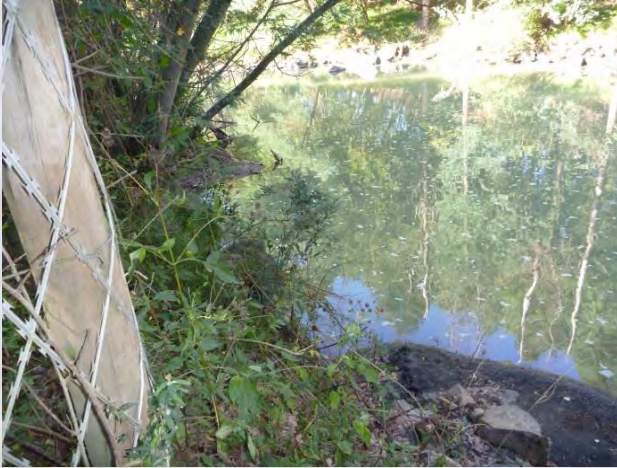
*Top left: Dargle: Fenced off river  
Middle left: Howick: Broken weir  
Bottom left: Durban: Illegal backfilling into river bed*

*Top right: Dargle: Water extraction pump station  
Middle right: Above Albert Falls: Fenced off river  
Bottom right: Durban: Illegal backfilling into river bed*

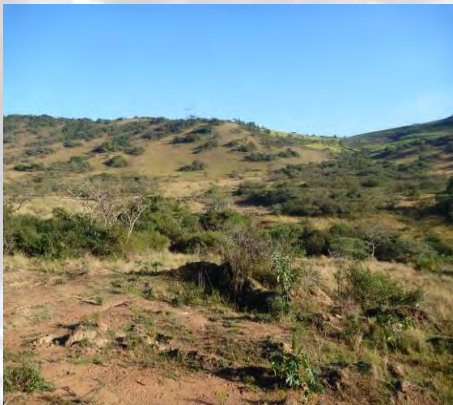
### Site #2: Right bank: Tributary stream below Cumberland Nature Reserve

Previously mined area has not been rehabilitated, although grass is growing back in some places. No levelling has taken place nor topsoil put back. Disturbed areas choked with *Lantana*, *Syringa*, *Sesbania*, *Cestrum*.

*Note mining on far side of stream*

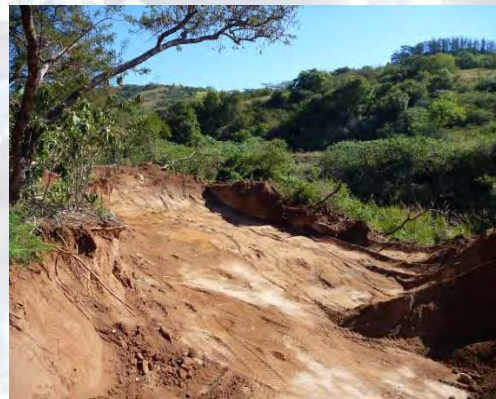
*Recent activity on stream bank*

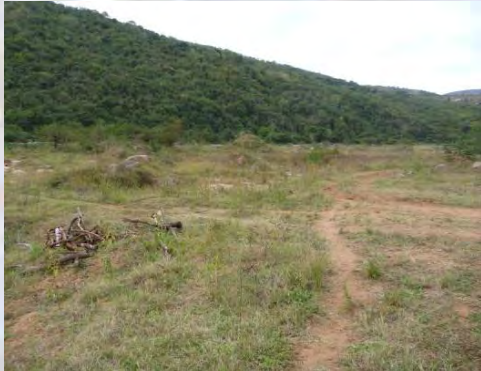
About 150m d/s of confluence. Old sand mining – all overgrown with grass. From river about 75m all the way up into the banks of the flood plain. Not rehabilitated.

*Un-rehabilitated area*

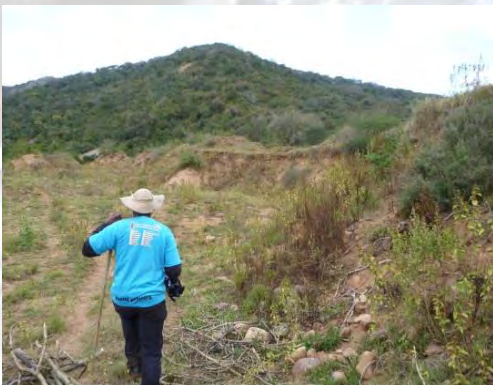
**Site #5: Right bank**

Mined from the river bank to the flood plain edge and d/s until the floodplain narrows near the river bend.

Mine was abandoned 2 years ago. Mining narrows right down where flood plain narrows near bend in river.

*Un-rehabilitated mine*

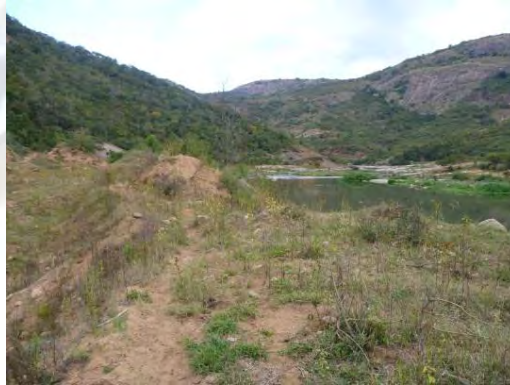
*Close proximity to river's edge*

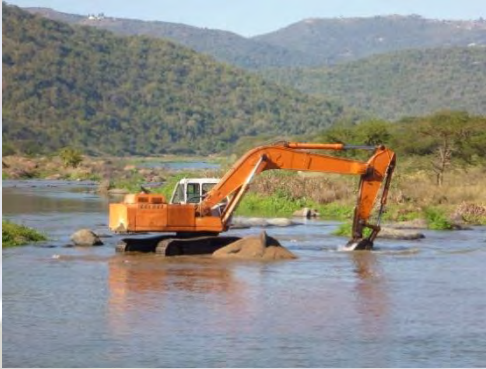
**Site #6: Left bank  
Active**

*Digging in the river*

Mining up to the rivers edge within 32m limit on most d/s point  
Mine stretches from where hill slope meets river banks. Stock piles being dumped in river, includes causeway crossing, with pipes.

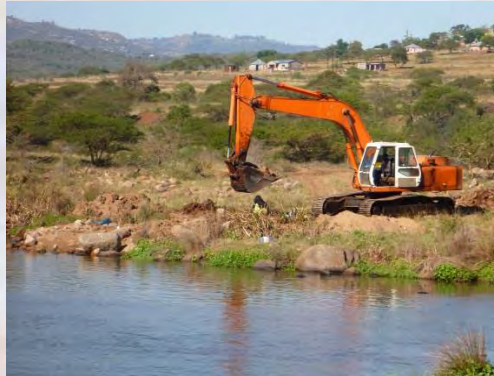
*Rock dumping rock the river: possible causeway?*

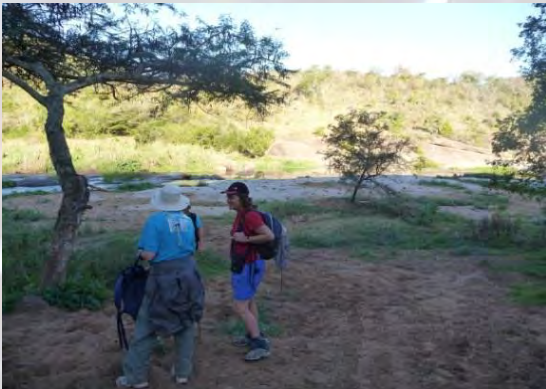
**Site #7: Left bank: Upstream of Imfula Store**

More sand mining: some very old, covered in grass, some not so old – looks new u/s of Mamba Gorge?  
On left is *Chromolaena* and Lantana!

More sand mining on river left between river and road that leads to Imfula  
More of the same sand mining operation still heading for Imfula

*Activity close to river bank*

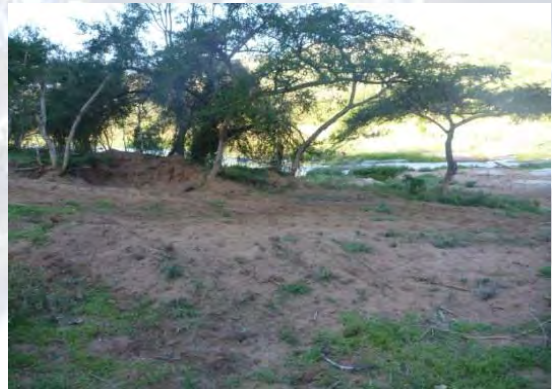
*Mining activity*

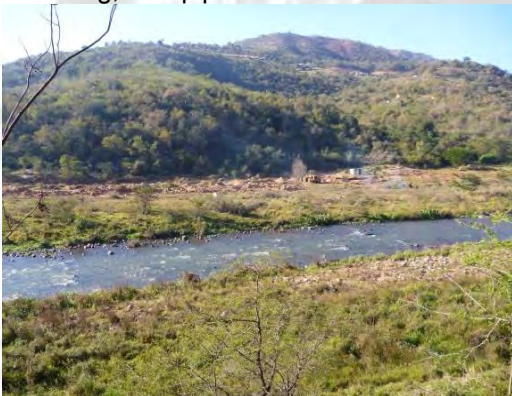
**Site #8: Right Bank: Downstream of Imfula Store  
Active**

*Portion of the mine*

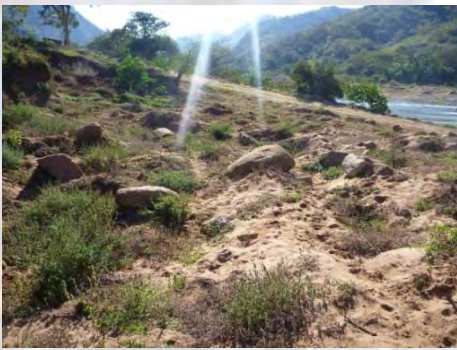
**Site # 9: Left & Right bank: Downstream of Imfula Store  
Abandoned**

Causeway across river. Was mined in 2011, since then has just been abandoned. All equipment was sold.

*Left bank – access and mining*

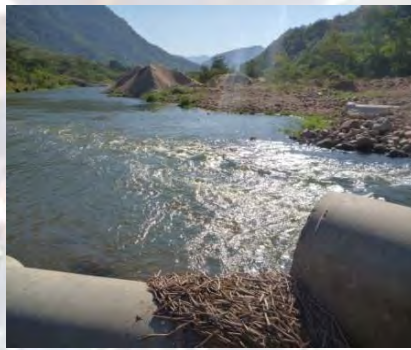
*Right bank – stockpiles*

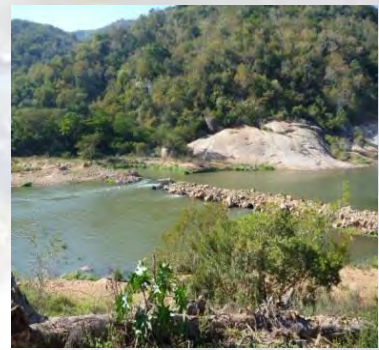
*Broken causeway*

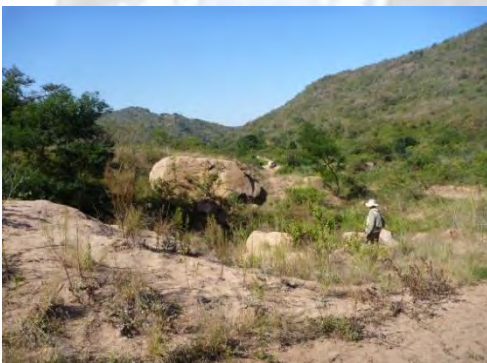
**Site # 10: Left bank: Downstream of large tributary stream entering uMngeni on left side  
Un-rehabilitated. Mining stopped about two years ago**

Left bank mined over 100 metres wide, u/s to the tributary confluence. Below tributary. The tributary splits into 2. The island has been mined. Almost all the trees have been bulldozed, just aliens coming up – area full of Peanut Butter Cassia, Wattle, *Chromolaena*, Syringa. *Chromolaena* emerging everywhere. About 100 m width of floodplain mined. A few scattered small indigenous trees.

*Un-rehabilitated area*

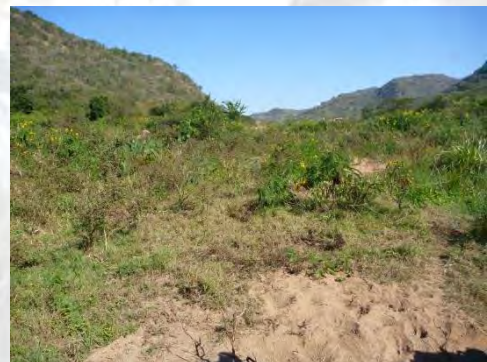
Mined area infested with Peanut Butter Cassia, Wattle, *Chromolaena*, Syringa, *Sesbania*, *Cestrum*, Mexican Sunflower, very large patch of bamboo.

*Alien plants in un-rehabilitated area*

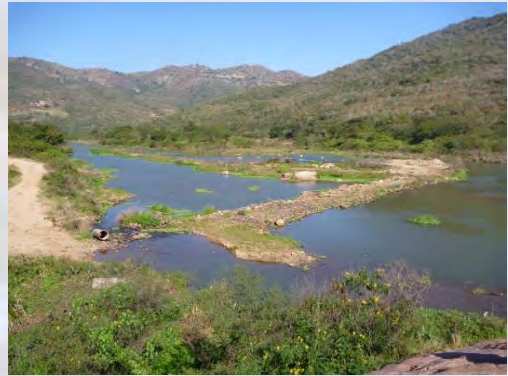
**Site # 11: Left bank**

Causeway slowing water flow. Only three large pipes in causeway. From the causeway all the way down on right bank is sand mining.

Access road to causeway constructed on left river bank, road raised like a dyke, recently used. Rock and earth bulldozed into the river to give a platform for equipment digging in river. Earth moving machine in middle of river.

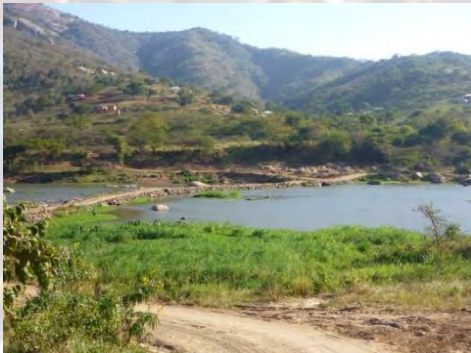
**Site #12: Right bank: Close to Mbetje Store**

D/s extent of sand mining that started opposite Mbeje. On left bank old sand mining. As one mine finishes on one bank it starts on the other bank. No rehabilitation.

*Mining on right bank*

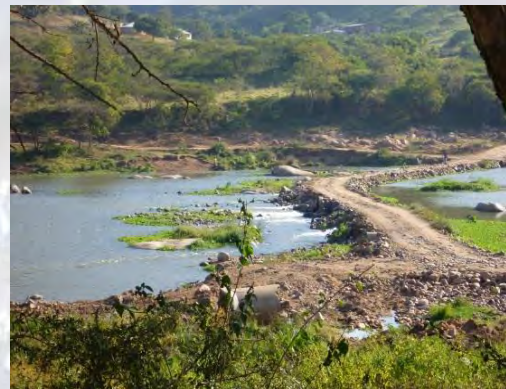
*Causeway to mining area*

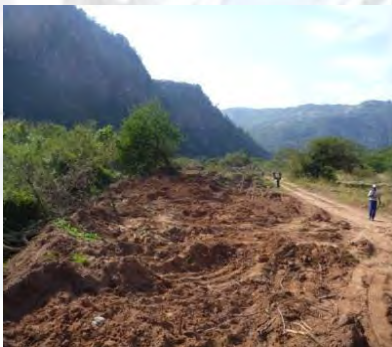
**Site #13: Right bank  
Un-rehabilitated Mine**

Mining taking place in the river – causeway halfway into the river, bulldozed to the river’s edge. Within the 32 metre river edge limit.

*Recent activity*

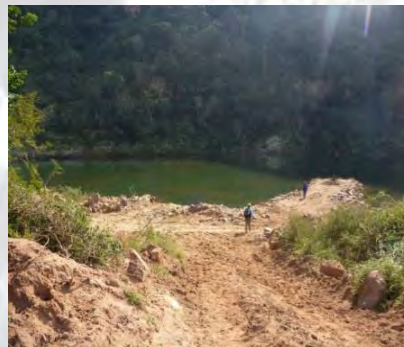
*Sand "causeway"*

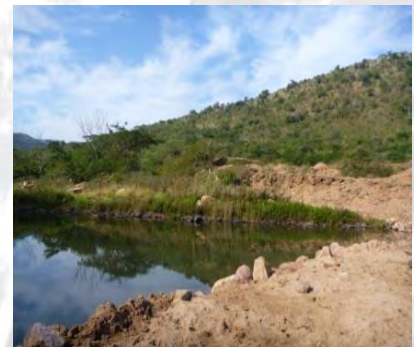
Right bank – bush has been cleared right into the river. Bulldozing into the river. *Chromolaena*, *Lantana*, Sickle Bush in previously mined areas

*River bank destruction*

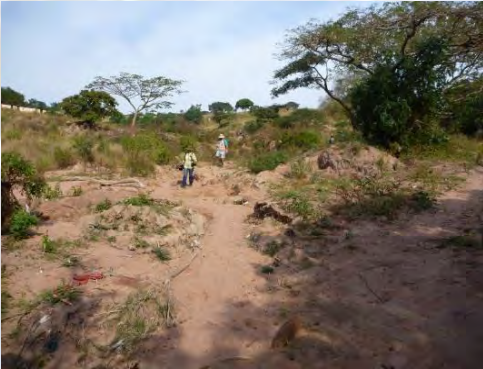
**Site # 17: Right bank**

Recent - could possibly be from bridge construction  
A river pool has been cut off and is choked with *Pistia* (Water Lettuce). Mexican Sunflower on banks

*Section of mined area*

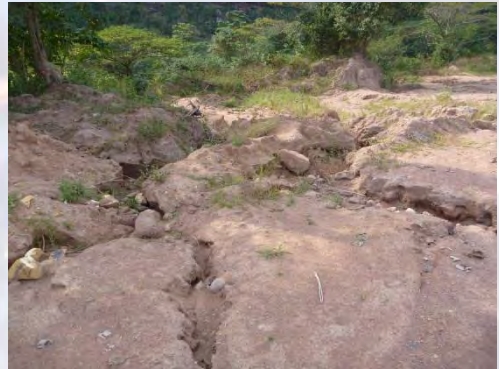
*Soil erosion from mined area*

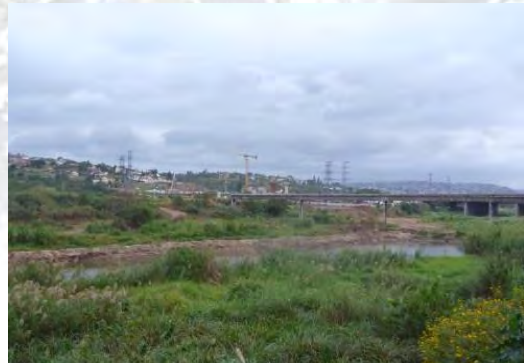
**Site # 18: Right bank, Left bank d/s of N2 highway bridge  
Active – Legal**

From upstream of N2 highway bridge to downstream of bridge

*Legal mining at N2 bridge*

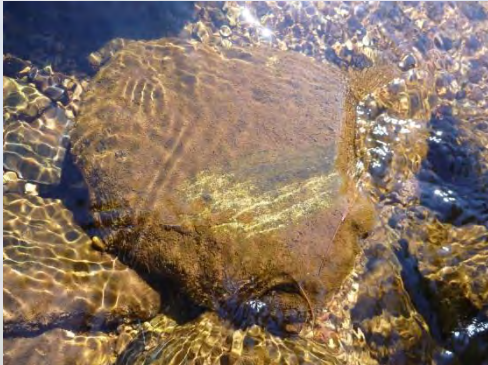
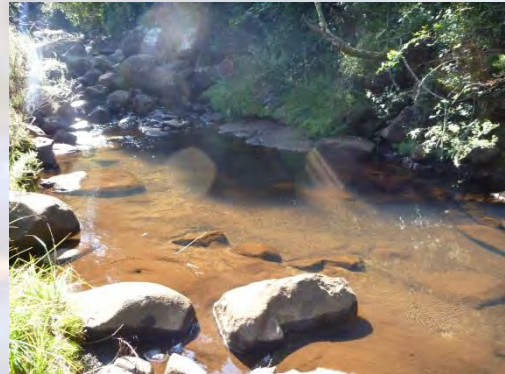
01-May **Mini SASS #1: Just u/s of uMngeni Poort Bridge**  
 Sediment (excess diatoms) on rocks u/s of Mini SASS site  
 Surrounding vegetation: Indigenous forest & grasslands

**Score: 7.1** Largely Natural / few modifications. GOOD condition

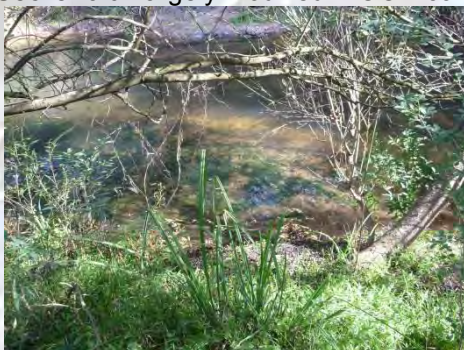
02-May **Mini SASS #2 : D/s of weir & bulldozed road**  
 First green algae  
 Bright green patch of algae on horseshoe bend. Horseshoe bend inundated with Wattle and Bugweed.  
 Road cleared with a bulldozer, less than 5 metres from stream edge. Medium infestation of Bugweed Bramble, river lined with Wattle trees  
 Surrounding vegetation; grasslands infested with Lantana, Bugweed, Wattle along river.  
 Surrounding land use: Cattle. Veld grazing. Some timber on higher ground  
**Score: 6.0** Largely modified. POOR condition.

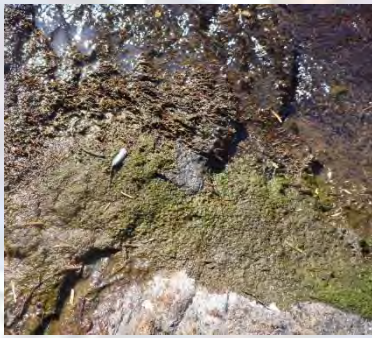
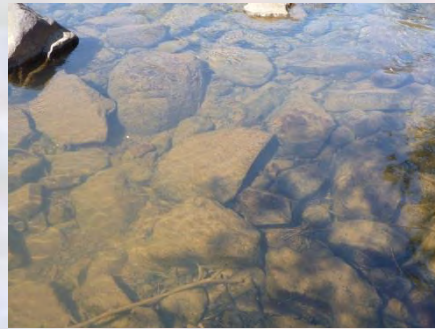
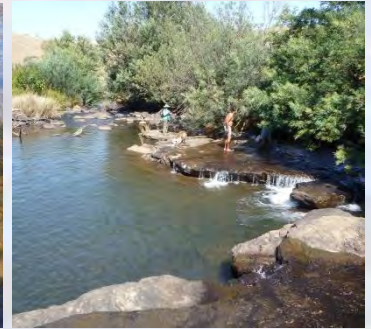
03-May **Mini SASS #3: Upper Dargle farm #1**  
 Algae above rapids, sediment on the rocks. Water mongoose at river.  
 Surrounding land use: Cattle, small arable lands. Poultry sheds in close proximity to river on opposite bank, but situated atop a high hill.  
 Surrounding vegetation : Veld grass infested with Brambles near river; Wattles along river.  
**Score: 7.0** Largely natural / few modifications. GOOD condition

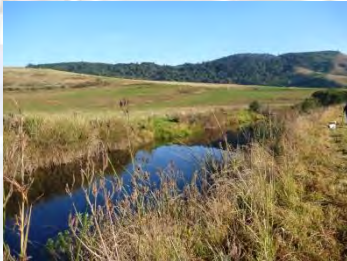
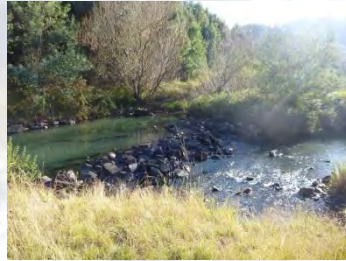
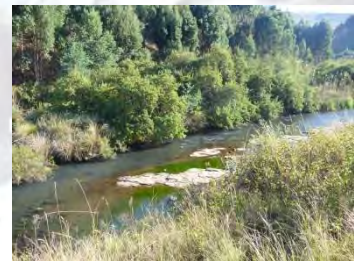
06-May **Mini Sass #4: Upper Dargle farm #2**

2-300m from Sass site on right of river Buddleja, Erythrina, Elephantorhiza  
 Surrounding land use: +-2km up stream, left bank - poultry and veld grazing. +-1km upstream, right bank - house & veld, +-1/2km upstream, right bank - holiday home & veld.  
 Surrounding vegetation : U/s natural river banks; on site - Bramble on one side bank, Pine & Wattle scrub other bank

**Score: 6.2** Moderately modified. FAIR condition

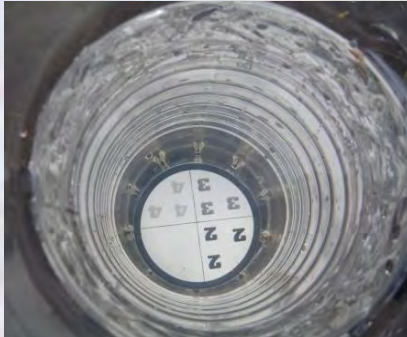
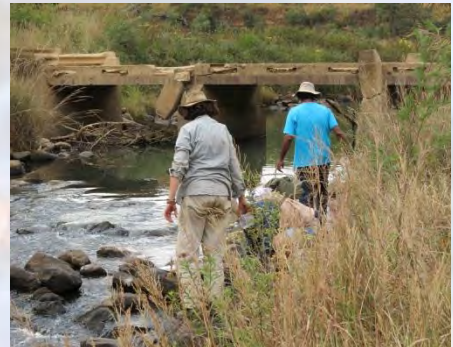
**Mini Sass #6: Petrus Stroom Farm #1**

Surrounding land use : Intense Poultry (19 sheds), intense cattle

Surrounding vegetation: Grasslands & kikuyu pastures. Various aliens. Wattles on river banks. Occasional indigenous river vegetation

**Score: 6** Largely modified. POOR condition

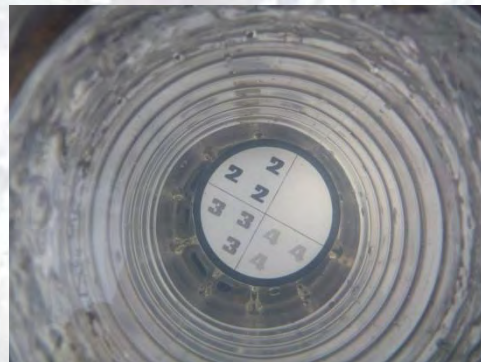
**Mini Sass # 7: Petrus Stroom Farm #2**

Surrounding land use: U/S Cattle, dairy. Pastures, irrigated crops. Test site situated between two houses in close proximity to river

Surrounding vegetation: U/S Kikuyu pastures, veld grass, indigenous alongside river. On site kikuyu lawn and mown veld grass, large scattered Blue Gum trees

**Score: 3.9** Seriously / critically modified (VERY POOR condition)

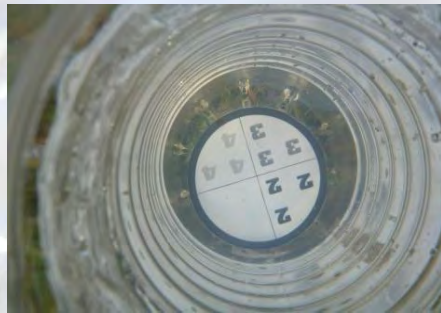
**Mini Sass #8: Howick : Midmar Dam: gauging weir d/s of dam wall near road bridge**

**Score: 5.1** Score on the edge between Seriously / critically modified (VERY POOR condition) and largely modified (POOR condition)

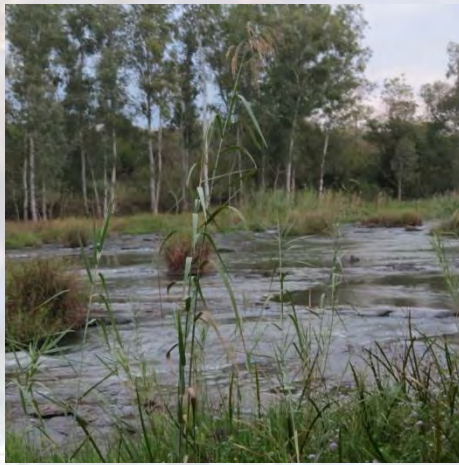
**Mini Sass # 14: Cumberland Nature Reserve**

**Score: 6.75.** On the top end of Moderately modified. FAIR condition. Highest score since upstream of Howick

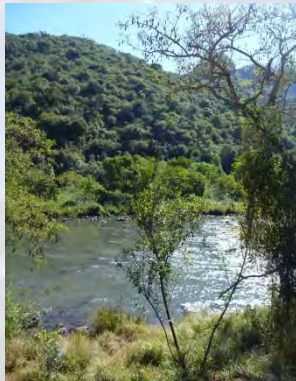
**Mini Sass #15: Upstream of Nagle Dam**

Surrounding land use: Nothing  
Surrounding vegetation: Valley Bushveld. Working for Water cleared two years ago – occasional *Chromolaena*  
**Score: 8.8** Unmodified NATURAL condition. Found a stone fly
